*Imagery Analysis*  
**North Korea's Camp No. 25, Update**  
June 5, 2014

THE COMMITTEE FOR  
HUMAN RIGHTS IN NORTH KOREA  
북한인권위원회

ALLSOURCE ANALYSIS

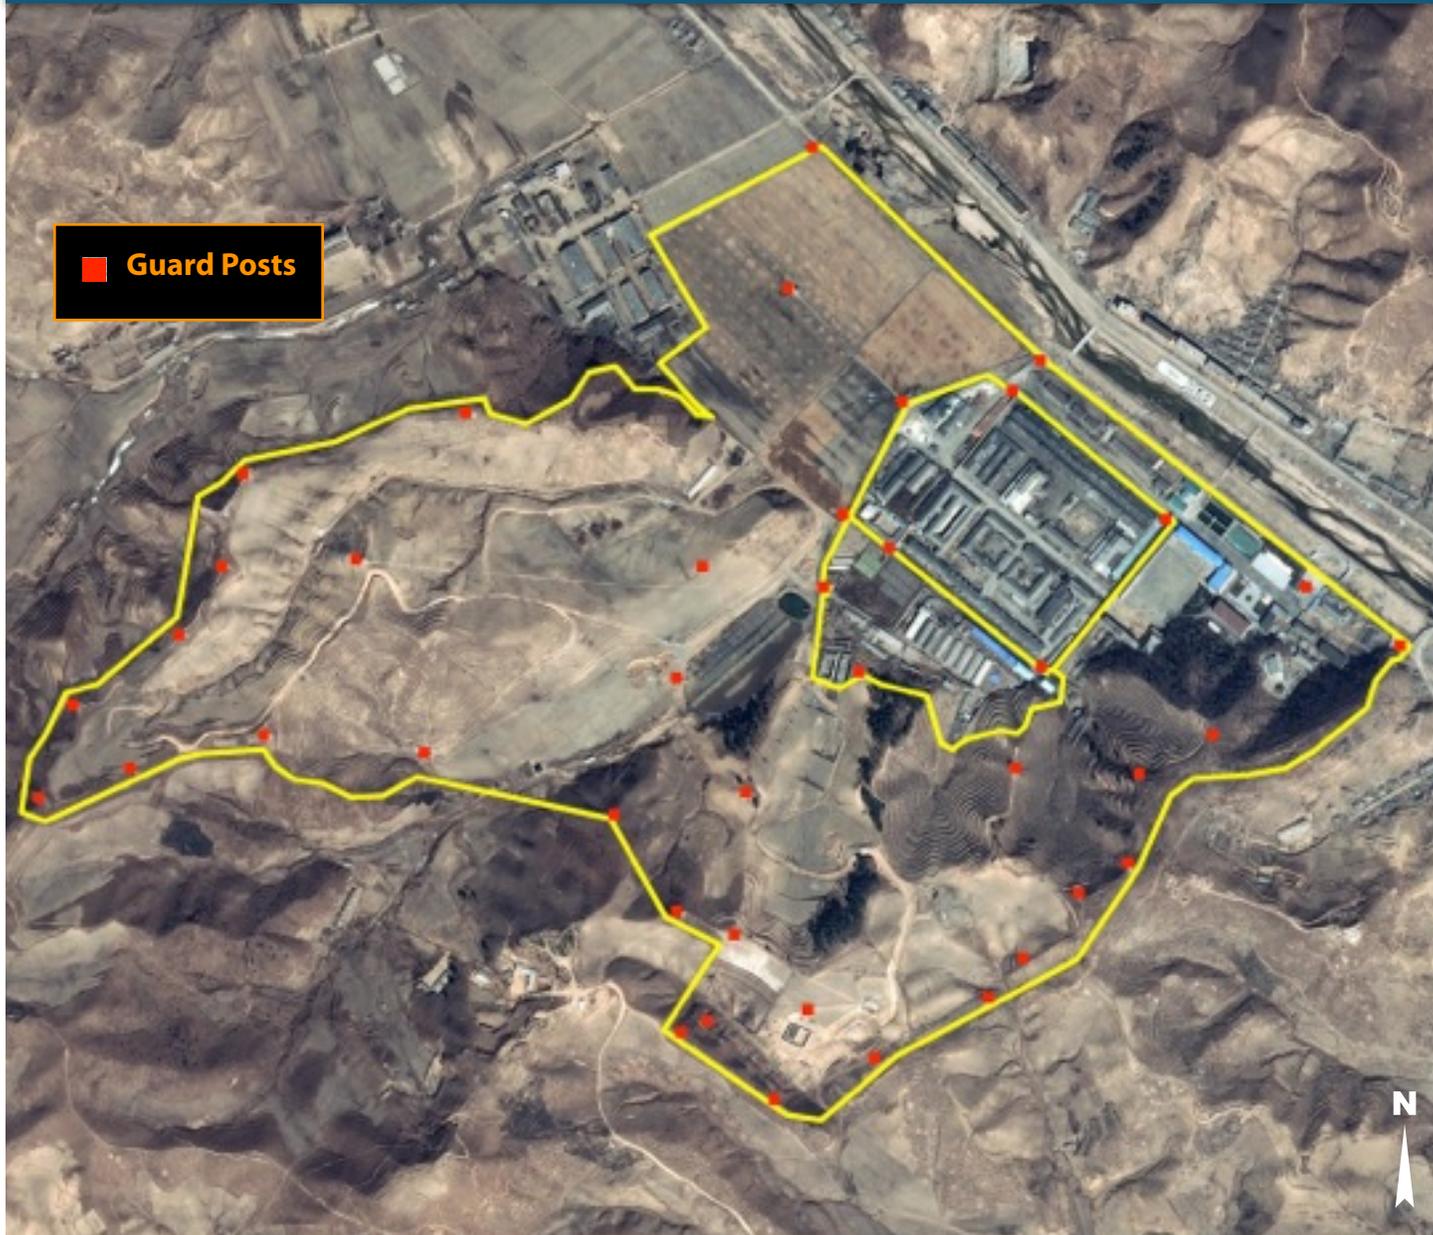
Figure 2, Camp No. 25 perimeter and guard posts, March 22, 2014.

A security perimeter consisting of walls, fences, gates and guard posts not only separates the camp from the surrounding countryside, but also divides it internally (Figure 2). Neither the security perimeter of the camp, nor the wall surrounding the central compound, have changed during the past year. The external perimeter is approximately 5,100-meters-long and has four facility entrance gates and possibly three footpath entrances. All walls, fences and gates are well maintained and in good repair, as are the perimeter patrol roads.

Including the guard posts at the main gates and administrative area entrances, there are a total of approximately 41 identifiable guard posts—24 along the perimeter, eight on the walls around the central compound and nine distributed internally.<sup>3</sup> While this is two less than identified in HRNK's 2013 report, this lower number is not significant and appears to be the result of routine adjustments made in agricultural activities around the camp. All guard posts are positioned to provide overlapping fields-of-view of the camp and are well maintained and in good repair. The absence of any vehicles along the perimeter patrol roads, or at the guard posts, suggests that guards rotate positions on foot rather than being shifted by vehicle.

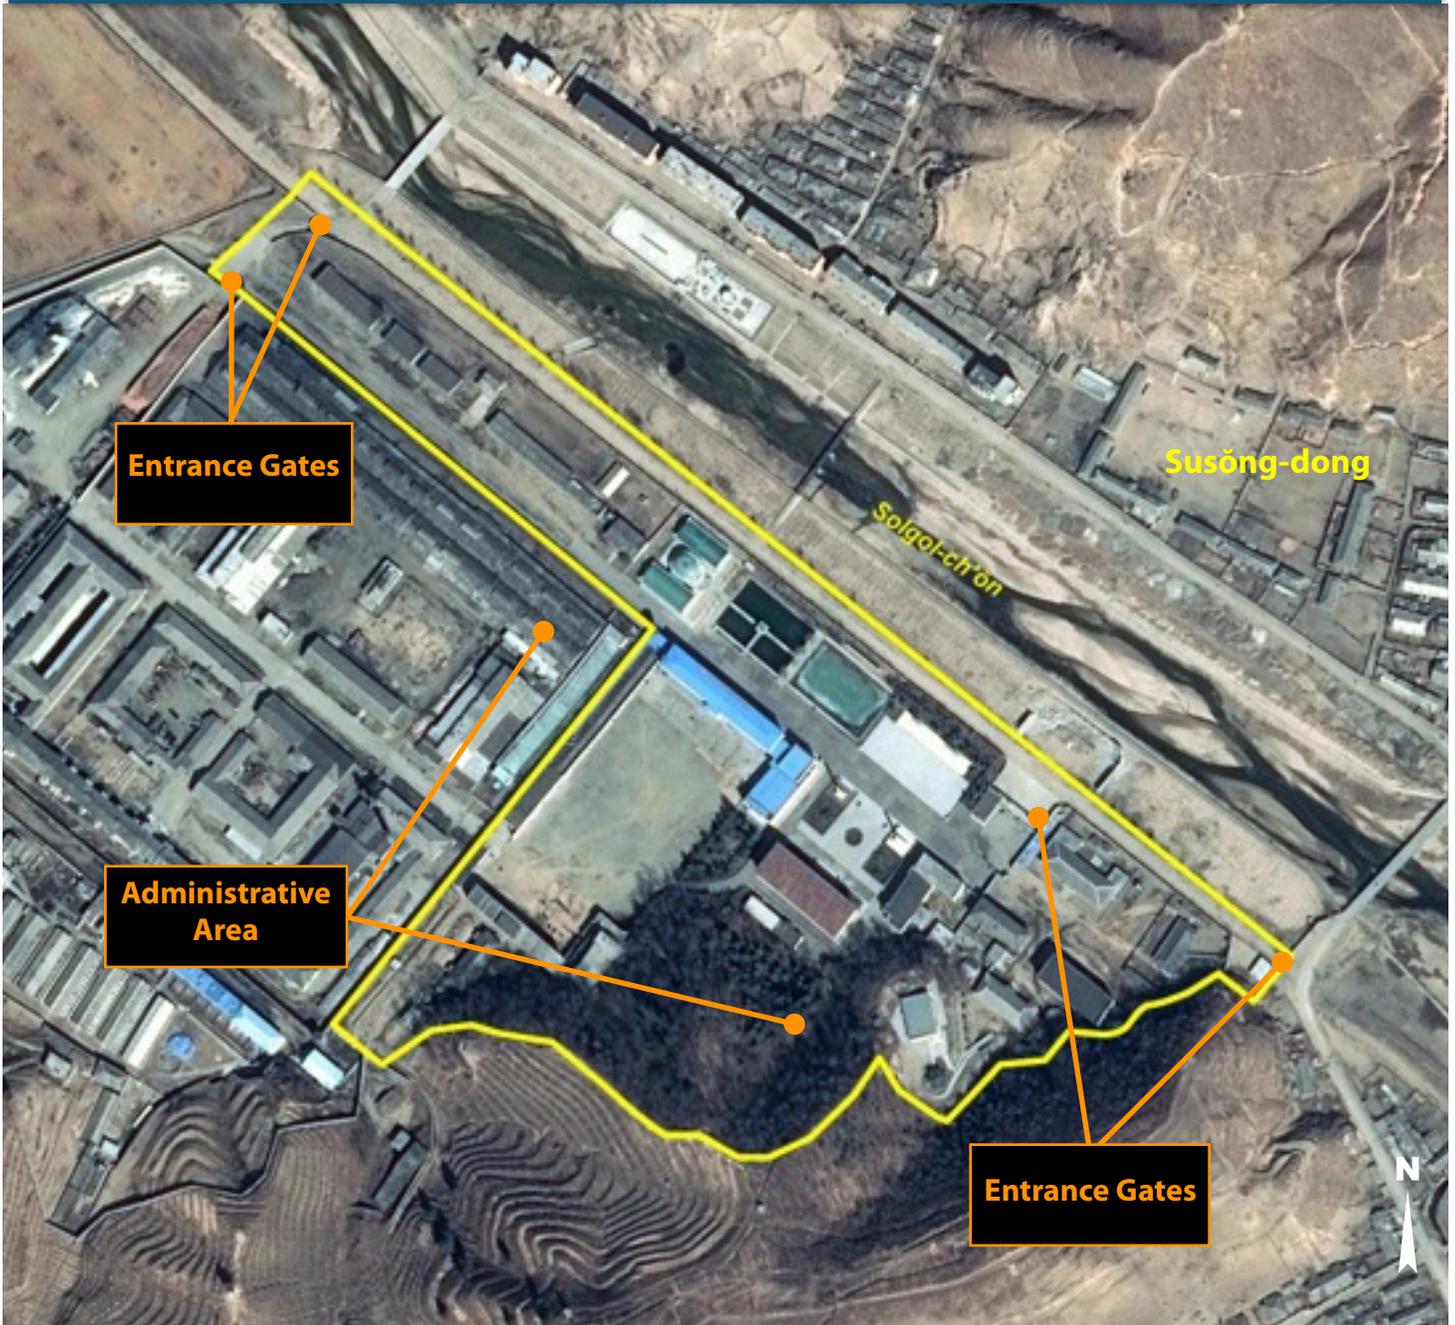
Figure 3, Administrative area and access road, March 22, 2014.

The administrative area consists of approximately 30 buildings, several monuments/memorials and a fishpond (Figure 3). Defector reports and imagery analysis indicate that the buildings are used for prison

administration, cultural welfare, housing, maintenance and other support functions. In the past, the central courtyard for the barracks has frequently been used by guards and staff as a football pitch (i.e., soccer field). No vehicles are visible in the latest satellite image and all buildings and grounds are well maintained and in good repair.

While there have been no significant changes within the administrative area during the past 12 months, a number of improvements have been undertaken along

the banks of the Solgol-ch'ŏn. Among these were the construction of retaining walls, removal of a temporary river ford, the grading of the land adjacent to both banks, completion of the approaches to the footbridge, construction of a park/sports facility on the Susong-dong side of the stream, and the start of construction on another facility of undetermined purpose on the Camp No. 25 side of the stream—opposite the main entrance to

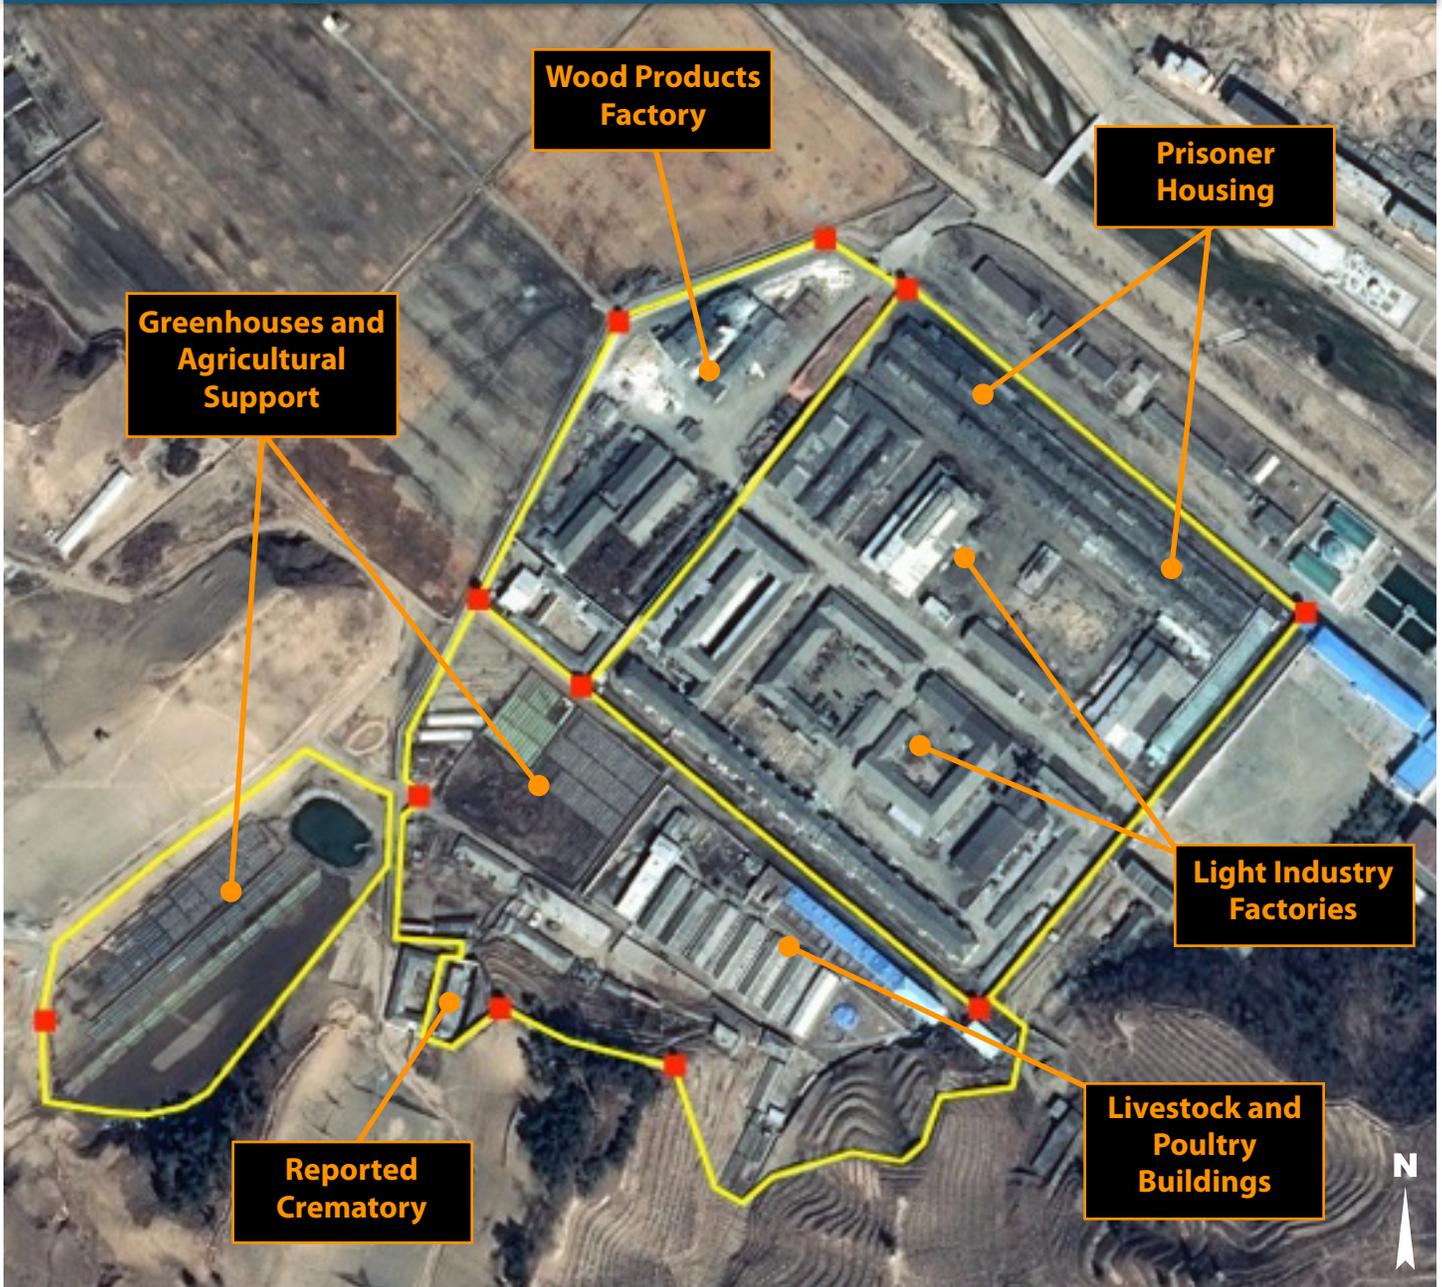
Figure 4, Central camp area, March 22, 2014.

prisoner housing and agricultural support areas (Figure 4). It is separated from the remainder of the camp by a barbed wire-topped wall with guard towers that is approximately 1,500-meters-long, encompasses approximately 13 hectares (32 acres) and has five gates.

The wood products factory consists of the factory buildings, lumber storage yard and wood chip storage areas. The central section consists of several light industrial factories and prisoner housing. The agricultural support area consists of greenhouses,

livestock or poultry pens, maintenance buildings, etc. On the western corner of the central area is a small walled-in building that has been described by defectors as a crematory. All walls, buildings and grounds are well maintained and in good repair. Both the wood products and light industrial factories appear to be operating, as is evidence by the presence of vehicles and supplies.

area is a fenced 1.74-hectare (4.2 acres) plot of land housing greenhouses. While the number of greenhouses visible at this site in the latest satellite image is higher than seen previously, this is the result of the consolidation of greenhouses previously distributed around the camp to this location.

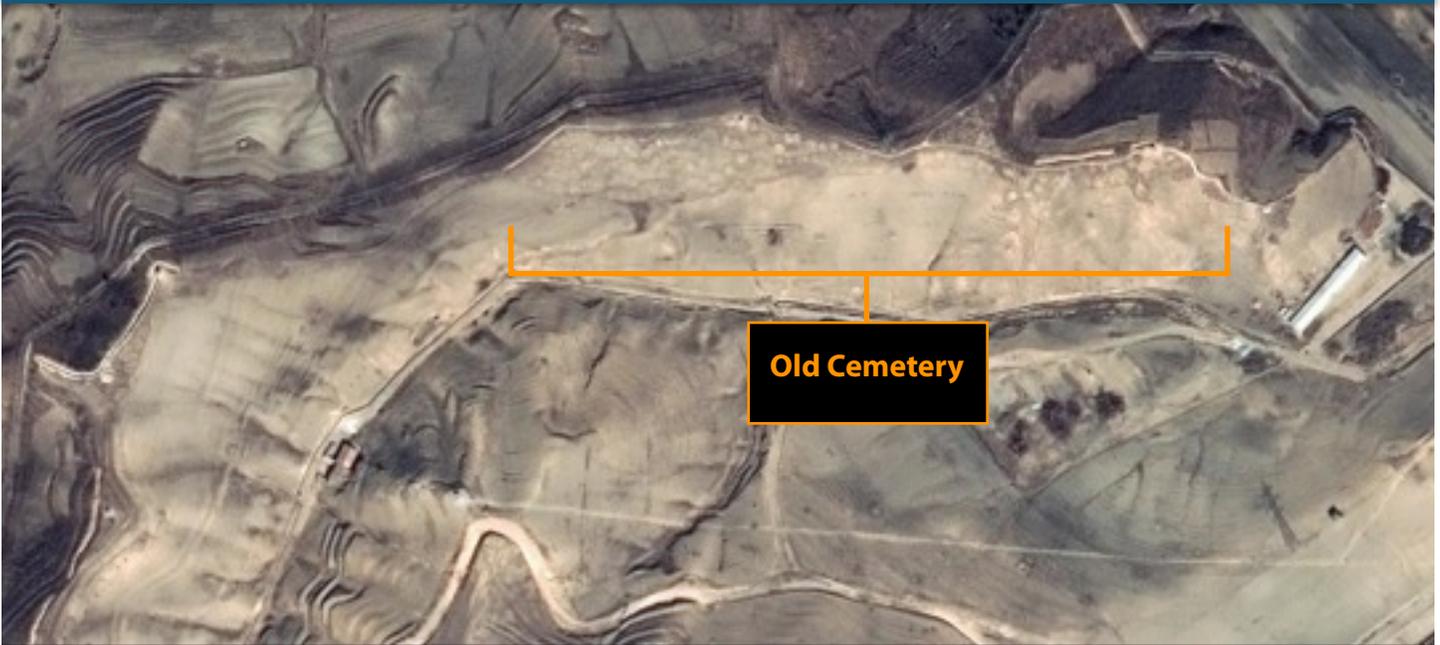
**Figure 6, Old cemetery on north side of Camp No. 25, March 22, 2014.**

cemetery within its northern boundary. Additionally, the southern boundary was extended up to another old cemetery. Neither of these cemeteries exhibits any evidence of activity during the period under study. This suggests that any Camp No. 25 prisoner deaths are dealt with by cremation or burial elsewhere (Figure 6).

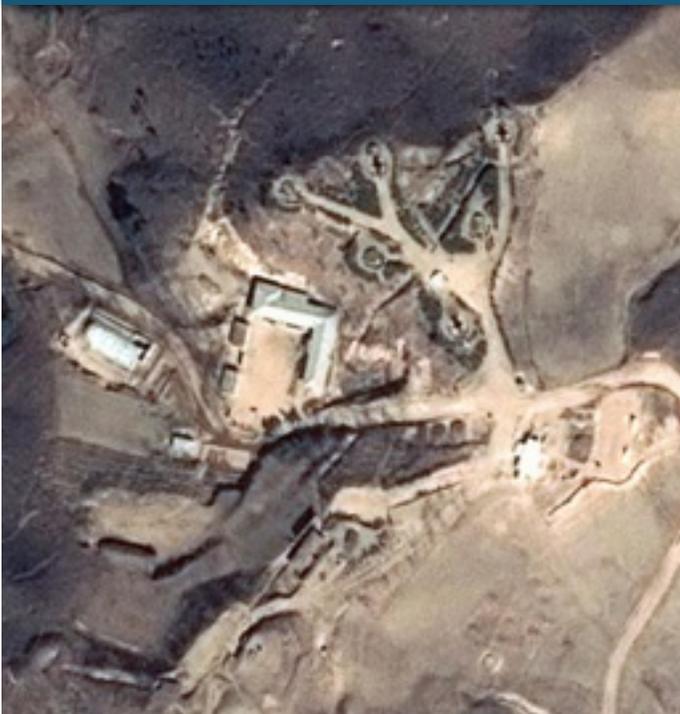
**Figure 7, Medium air defense artillery battery position, March 22, 2014.**

Immediately adjacent to Camp No. 25's perimeter are two air defense artillery sites—one to the west and one to the south. The position to the west consists of a battery of six medium-caliber anti-aircraft guns, while the position to the south consists of a battery of eight light-caliber anti-aircraft guns. Both sites consist of headquarters, barracks, support buildings and firing

protection to Camp No. 25, they are more correctly components of the integrated air defense of Chŏngjin (Figure 7).
