North Korea Camp No. 25 - Update 2

North Korea: Imagery Analysis of Camp No. 25 - Update 2

Susŏng-dong, Ch'ŏngjin-si,
Hamgyŏng-bukto

August 26, 2016

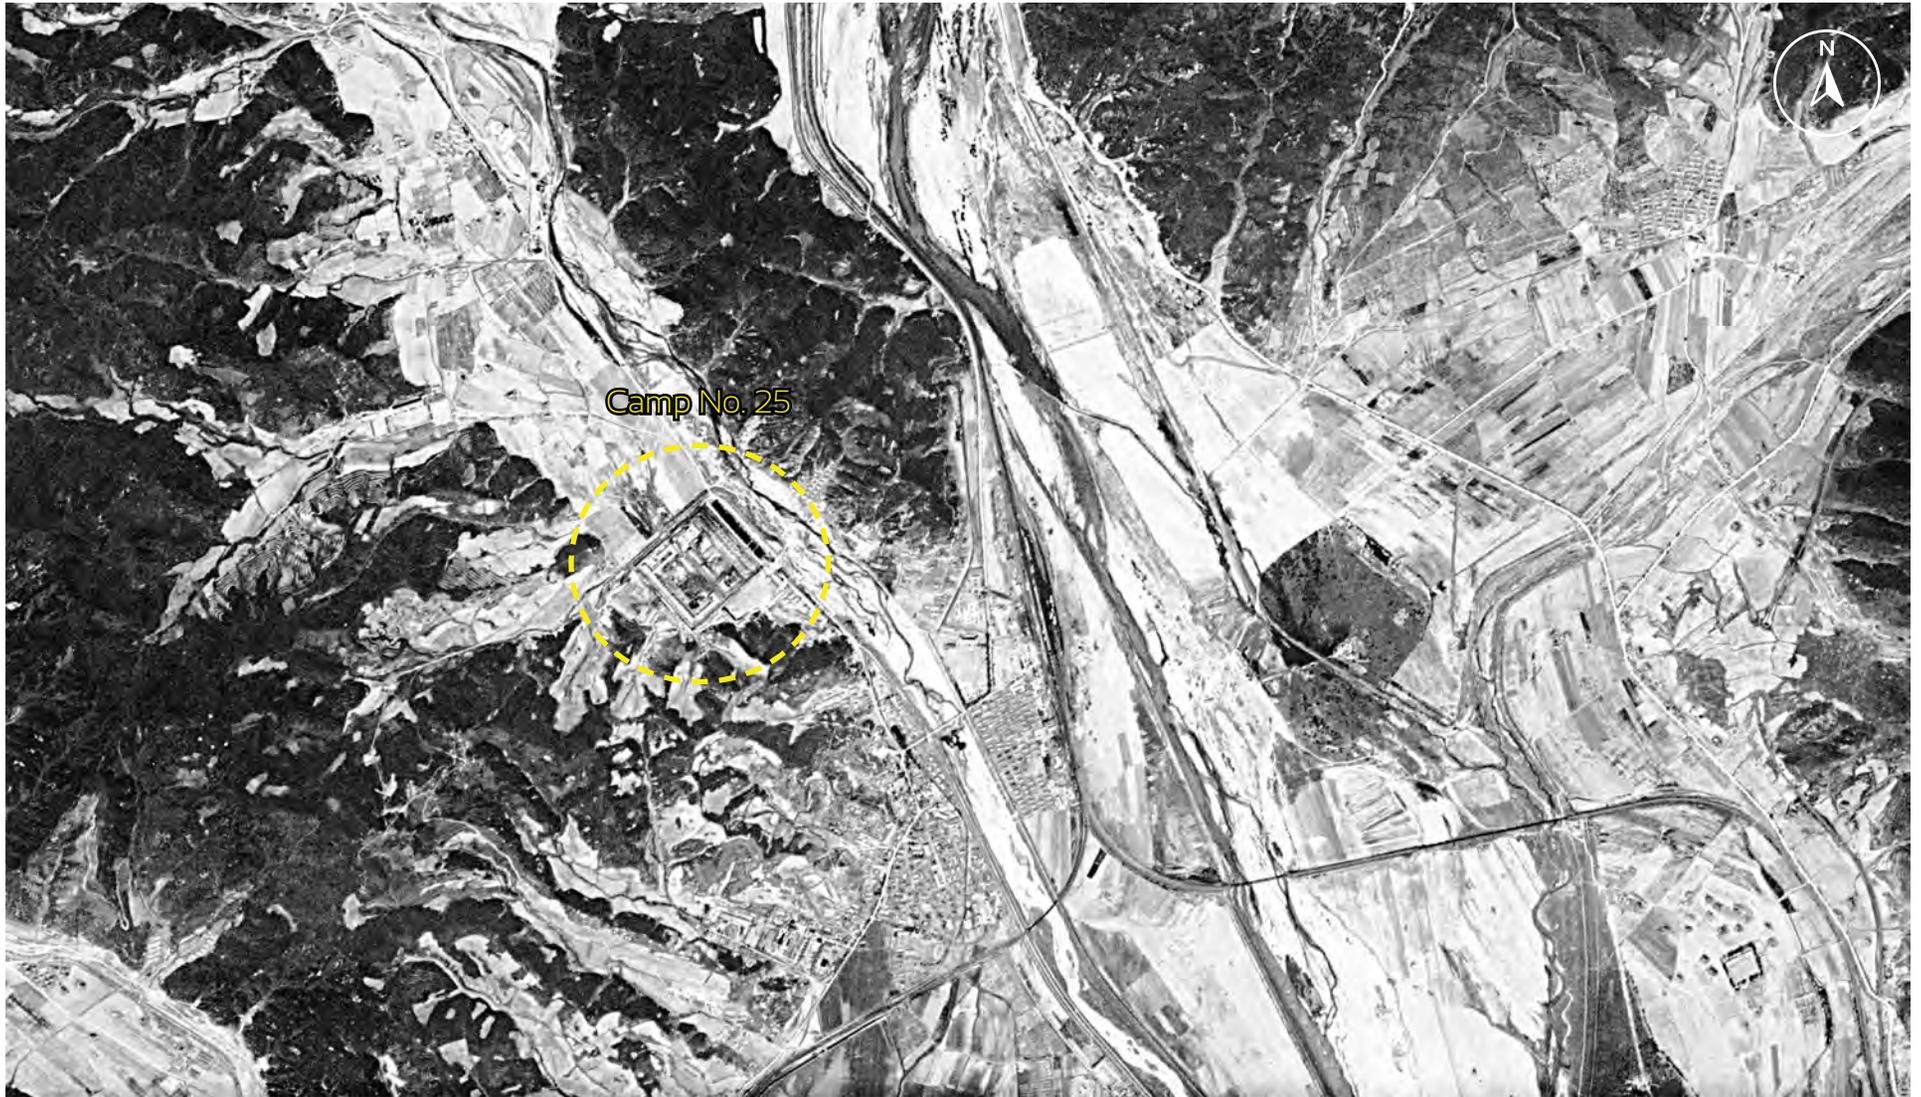
Figure 1

Overview of the Camp No. 25 area as seen in a declassified Top Secret KH-4B satellite image dated May 28, 1970. (41.8374 N, 129.7346 E)

square yards) and was expanded slightly by January 27, 1976, when it measured approximately 700 meters by 315 meters (765 yards by 344 yards) and encompassed 15.30 hectares (181,987 square yards) (Figure 1, Figure 2).⁶

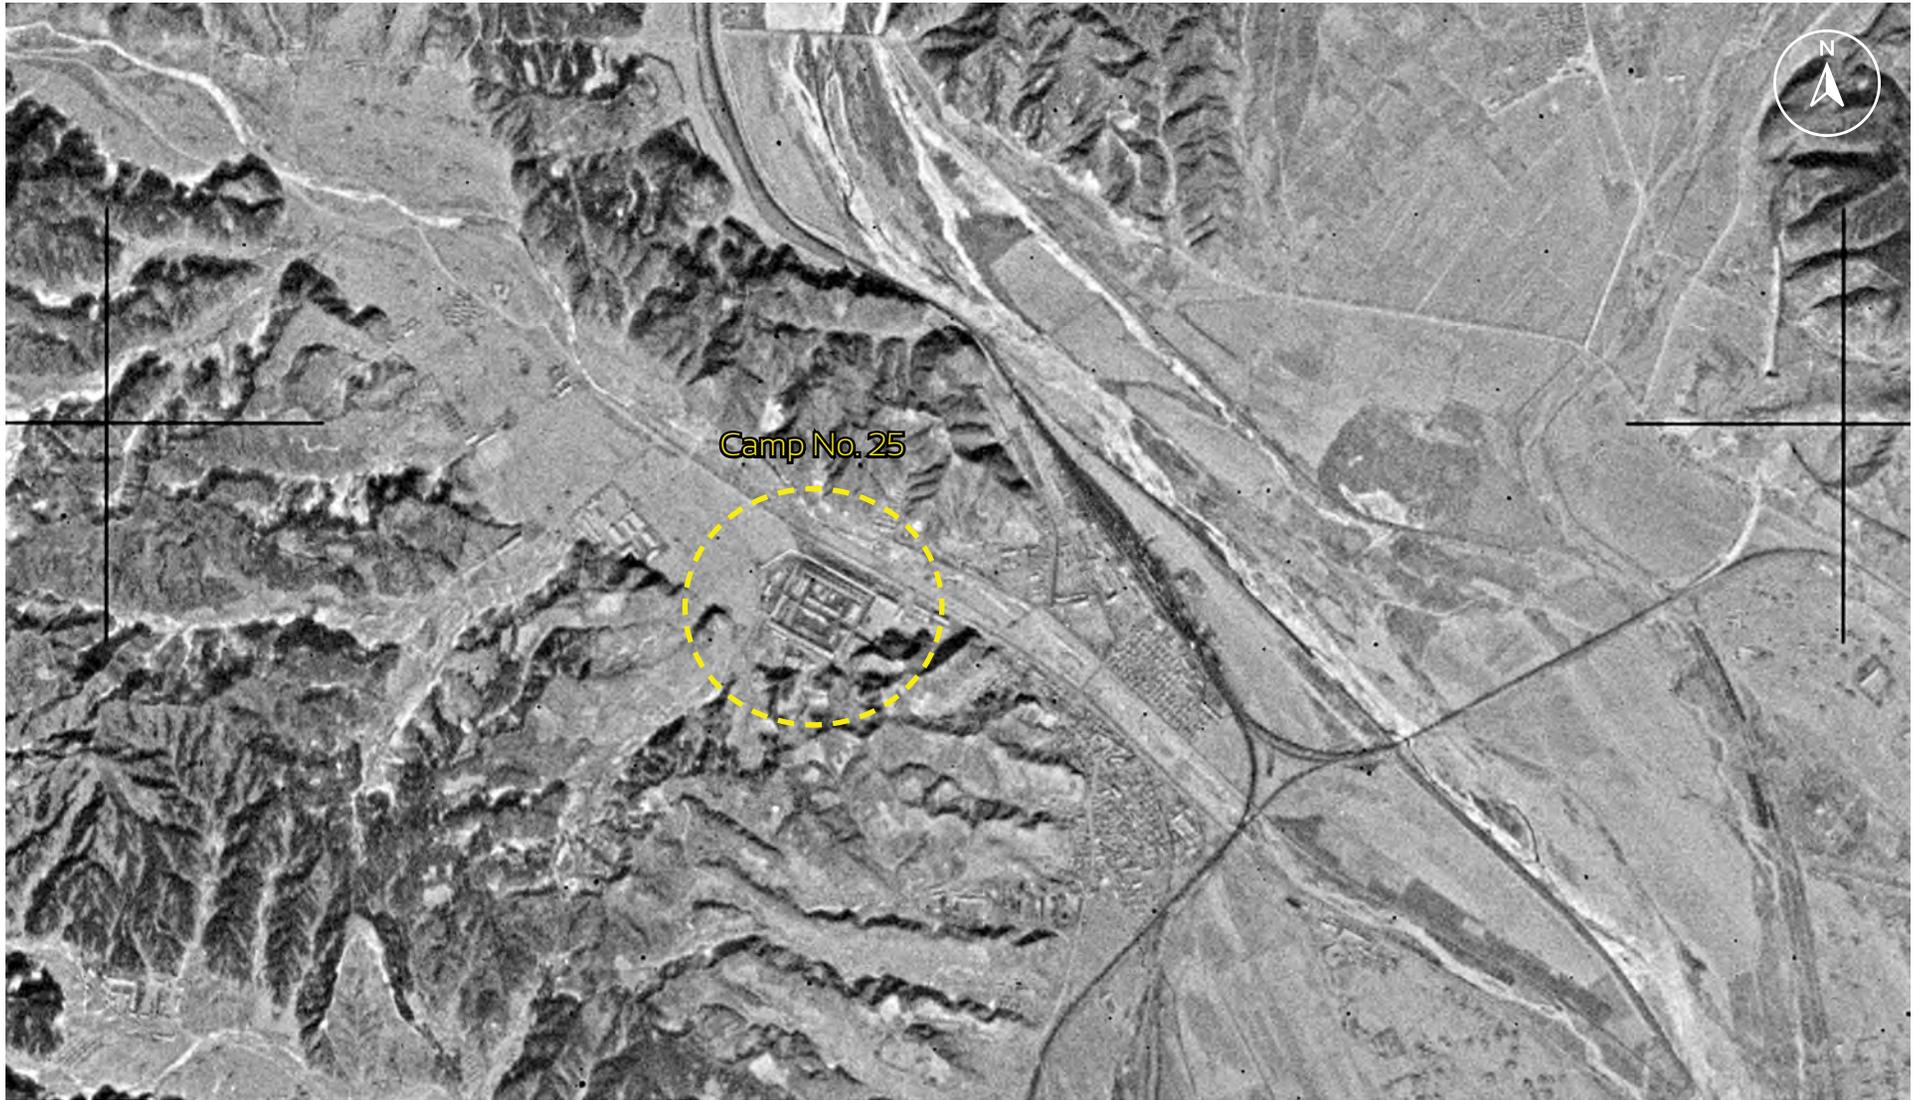
Figure 2

Overview of the Camp No. 25 area as seen in a declassified Top Secret KH-4B satellite image dated January 1, 1976. (41.8354 N, 129.7297 E)

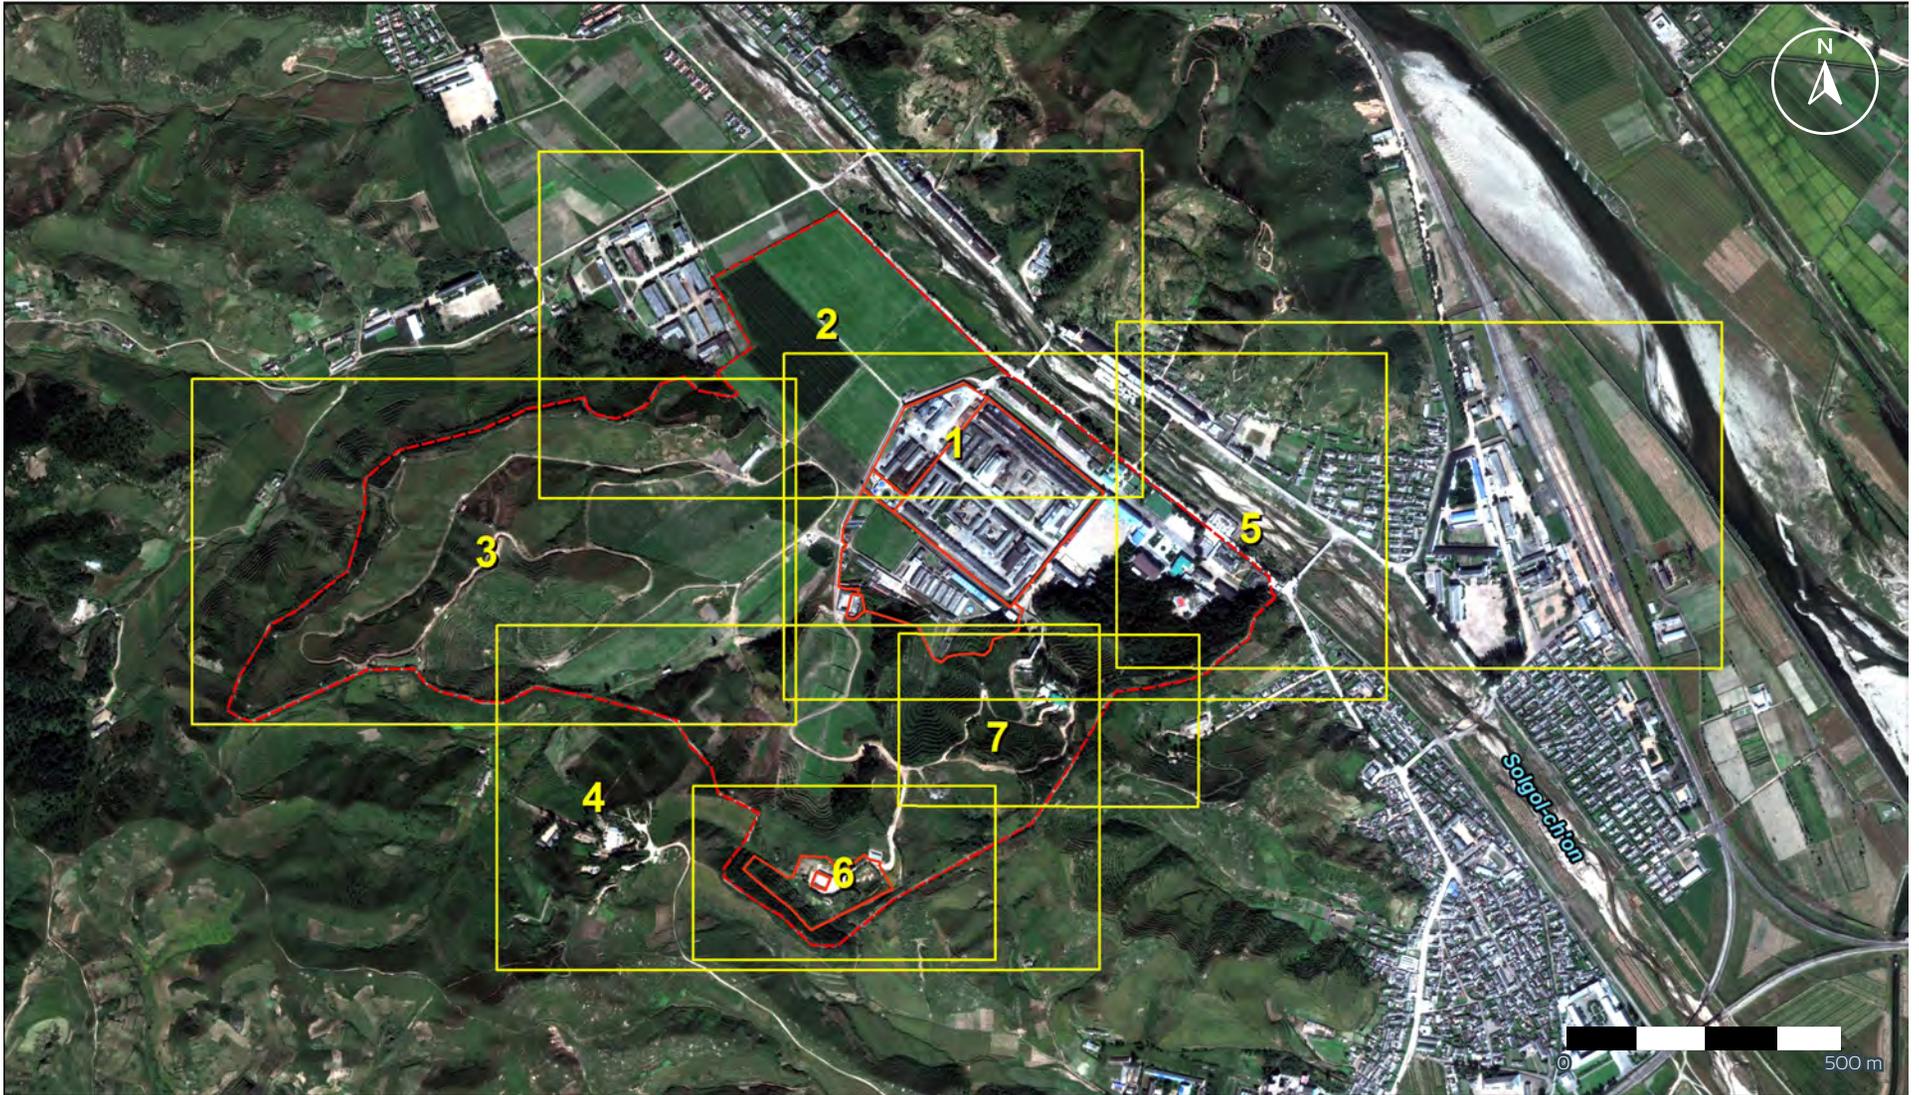
Figure 17

Based on previous HRNK satellite imagery reports, publicly available information, and high resolution satellite imagery, Camp No. 25 and its immediate surroundings can be separated into five broad areas (Figure 17):

Camp No. 25 report areas, September 21, 2015. (41.833 N, 129.725 E)

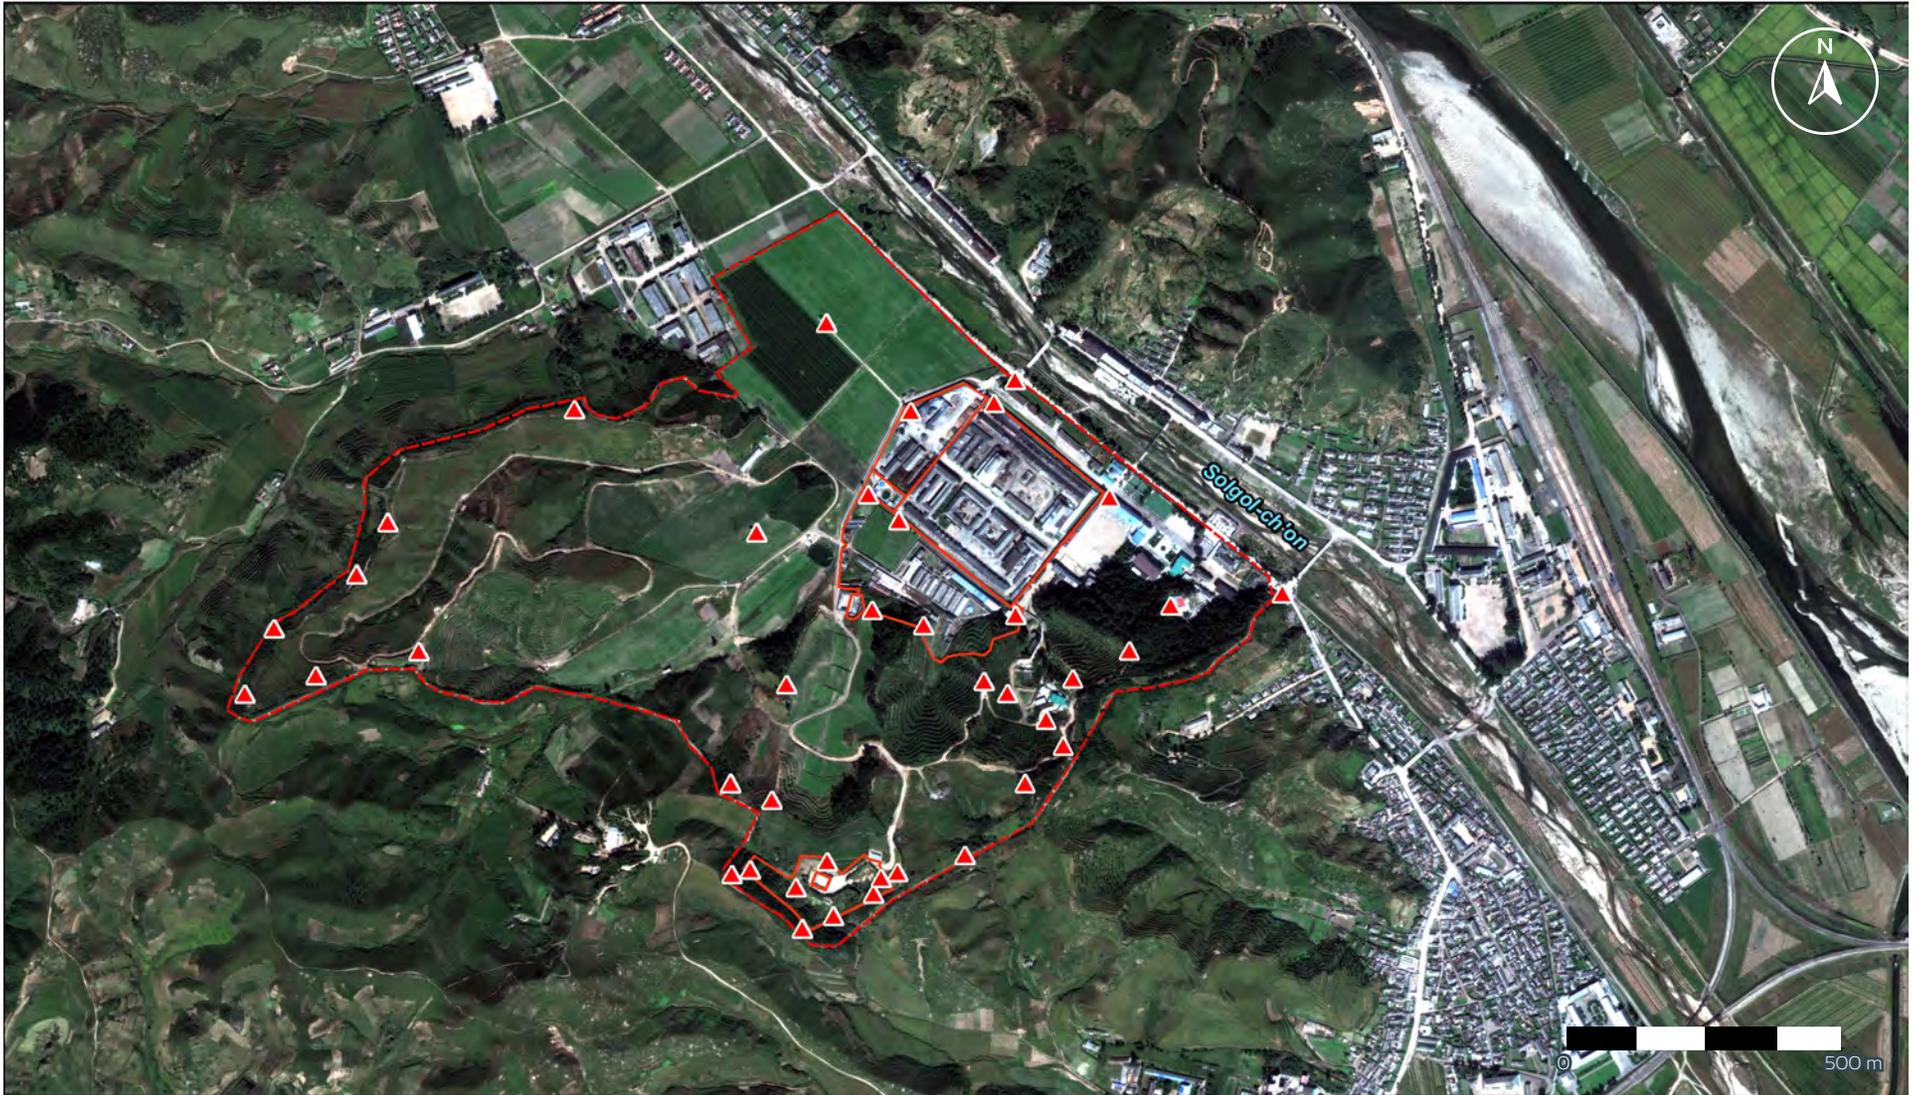
Figure 18

A security perimeter consisting of a combination of walls, fences, gates, and guard positions not only separates Camp No. 25 from the surrounding countryside but also segments it internally (Figure 18). Neither the external perimeter of the camp nor the wall surrounding the central compound has changed signifi-

cantly since our 2014 report. The external perimeter is approximately 5,100 meters long, encompasses approximately 100 hectares (.389 square miles), and has seven internal and external entrances. All walls, fences, and gates are well maintained and in good repair, as is the perimeter patrol road. There is a main entrance and checkpoint astride the only road leading into the shallow valley in which Camp No. 25 is located. The walled prison component of the camp occupies a generally irregular-shaped area that measures approximately 350 meters by 410 meters (382 yards by 448 yards) and encompasses 12.628 hectares (151,030 square yards).

Including the guard positions at the main and administrative area entrances, there are a total of 40 identifiable guard positions—22 along the perimeter, eight on the walls around the central compound, and ten distributed internally.⁸ Although this is one less than identified in HRNK's 2014 report, this lower number is not significant and appears to be the result of routine adjustments made in agricultural activities around the camp. All guard positions are well positioned

to provide overlapping fields-of-view of the camp and are well maintained and in good repair. The absence of any vehicles along the perimeter patrol roads or at the guard positions suggests that guards rotate positions on foot rather than being shifted by vehicle.

During the period under study, the camp grew in physical size. In 2003, there were approximately 20 guard positions strategically placed throughout the camp. New positions were slowly erected, with two added in 2007 and four in 2009. From 2003 through 2009, the camp had a perimeter of approximately 3,650 meters (3,991 yards) and encompassed 56.950 hectares (681,147 square yards). During 2010, however, the perimeter was dramatically expanded to approximately 5,100 meters (5,577 yards), and the area enclosed increased to 101 hectares (.389 square miles)—a 37 percent and 72 percent increase, respectively. With this expansion, a new main gate was erected, two previously separate agriculture fields in the northwest area of the camp were combined, the road between fields was blocked off, and 17 additional guard positions were erected, predominately along the new perimeter line. The security perimeter has remained essentially unchanged since 2013, and all guard positions and entrances appear to be well maintained and in good repair.

Camp No. 25 Perimeter and Guard Positions, September 21, 2015. (41.833 N, 129.725 E)

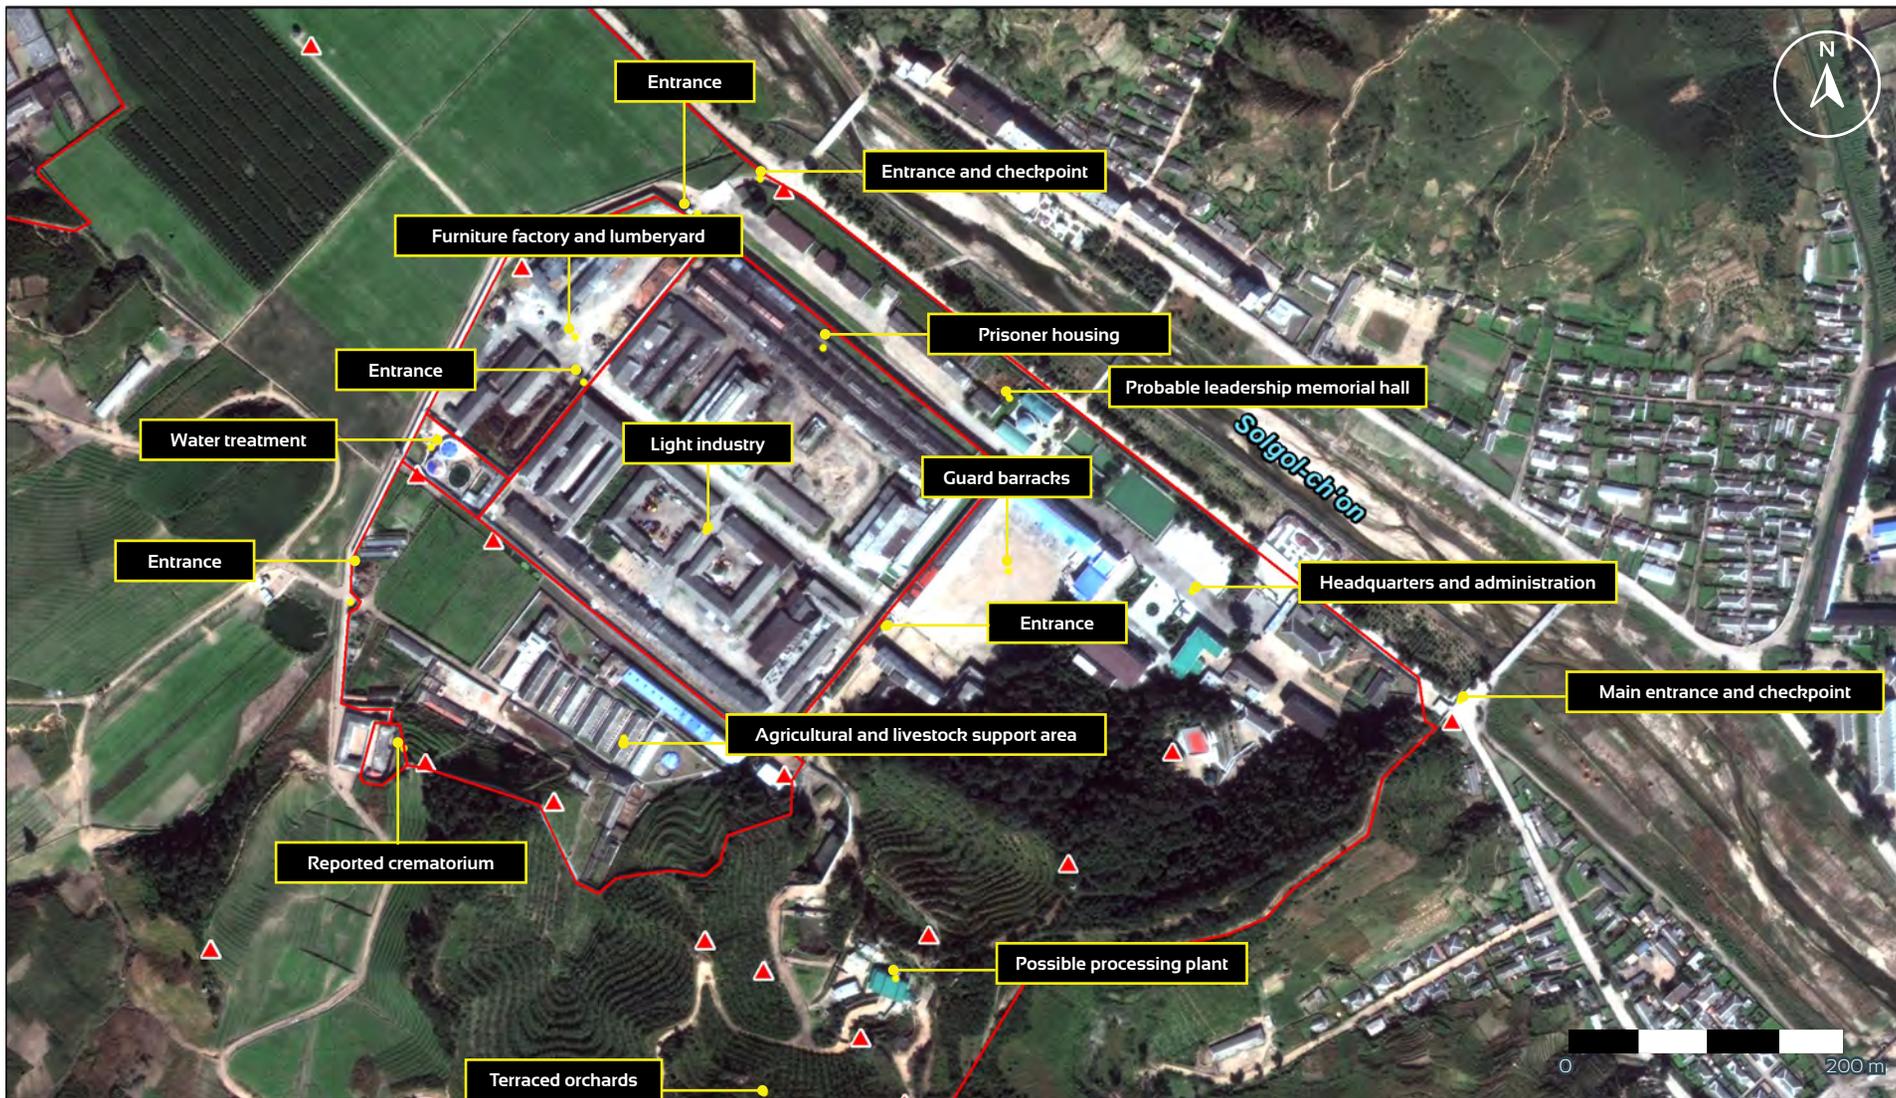
Figure 19

The administrative area consists of approximately 30 buildings, several monuments/memorials, and what appears to be a fishpond (Figure 19). Escapee reports and imagery analysis indicate that the buildings are used for prison administration, cultural welfare, housing, maintenance, and other support functions.⁹ In the past, the central courtyard for the barracks had frequently been used by guards and staff as a football pitch (i.e., soccer field). Only one vehicle is visible in

the latest satellite image, and all buildings and grounds are well maintained and in good repair.

The central camp consists of an irregular-shaped walled-in compound composed of wood products, light industrial, prisoner housing, water treatment, and agricultural support areas. It is separated from the remainder of the camp by a barbed wire-topped 5-meter-high wall with eight guard towers that is approximately 1,450-meters-long, encompasses 12.628 hectares (151,030 square yards) and has seven gates.

The wood products area consists of two milling and three factory buildings, a lumber yard, and wood chip storage bins. It is separated from the central compound by a wall with a gate. The central compound consists of several light industrial buildings and prisoner housing. One of the light industrial buildings is, according to escapees, used to manufacture bicycles using hand tools. A number of trucks are often present in the courtyard of the central industrial facility. This area has seen little change during the period under study, although several light industrial buildings were razed between 2006 and

2007. Prisoner housing consists of a large 218 meter by 34 meter (238.4 yards by 37.2 yards) double-arched, roofed building that is sub-divided into four sections. There are numerous monitors (sometimes called clerestories) along the lengths of the roofs. This structure is in a moderate state of repair.

All walls, buildings, and grounds appear to be generally well maintained and in a moderate state of repair. Both the wood products and light industrial factories appear to be operating, as evidenced by the presence of vehicles and supplies.

Central Compound and Administrative Areas, September 21, 2015. (41.833 N, 129.727 E)

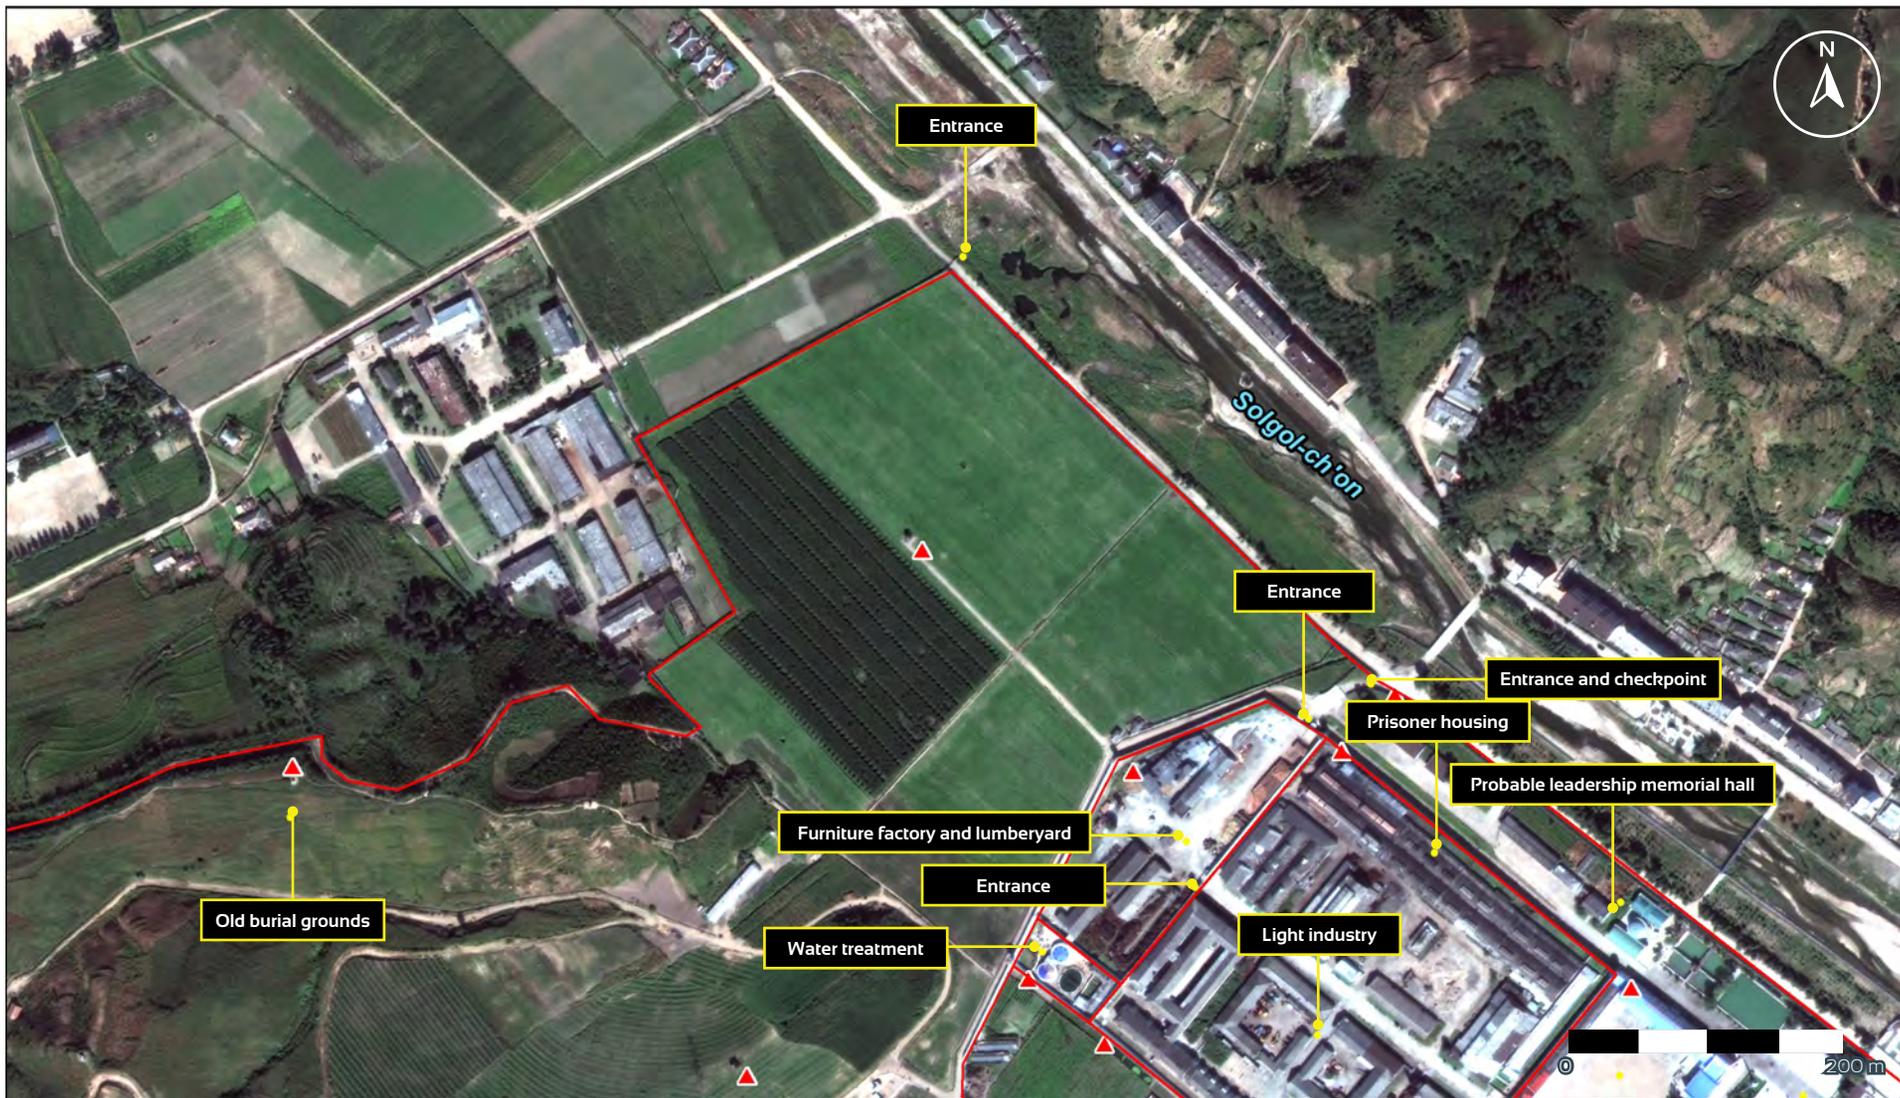
Figure 20

Located within the camp's perimeter are approximately 79 hectares (0.3 square miles) of cultivated fields of grain crops immediately north of the central camp and orchards on the hillsides to the west and south (Figure 20). During 2010, there was an expansion of the camp's outer perimeter to encompass more land for agricultural. On the east side the wall separating the camp from the two flat agricultural fields immediately to the north was razed and a new wall erected encompassing them. Guard towers were placed in the center of these fields to provide full coverage of the expanded perimeter. During 2012, a large greenhouse was erected on the west side of these fields, on the northern perimeter. Subsequently, during 2015, a new variety of crop was planted in the western portion of the two fields (Figure 21).

Northern Agricultural Area, September 21, 2015. (41.836 N, 129.723 E)

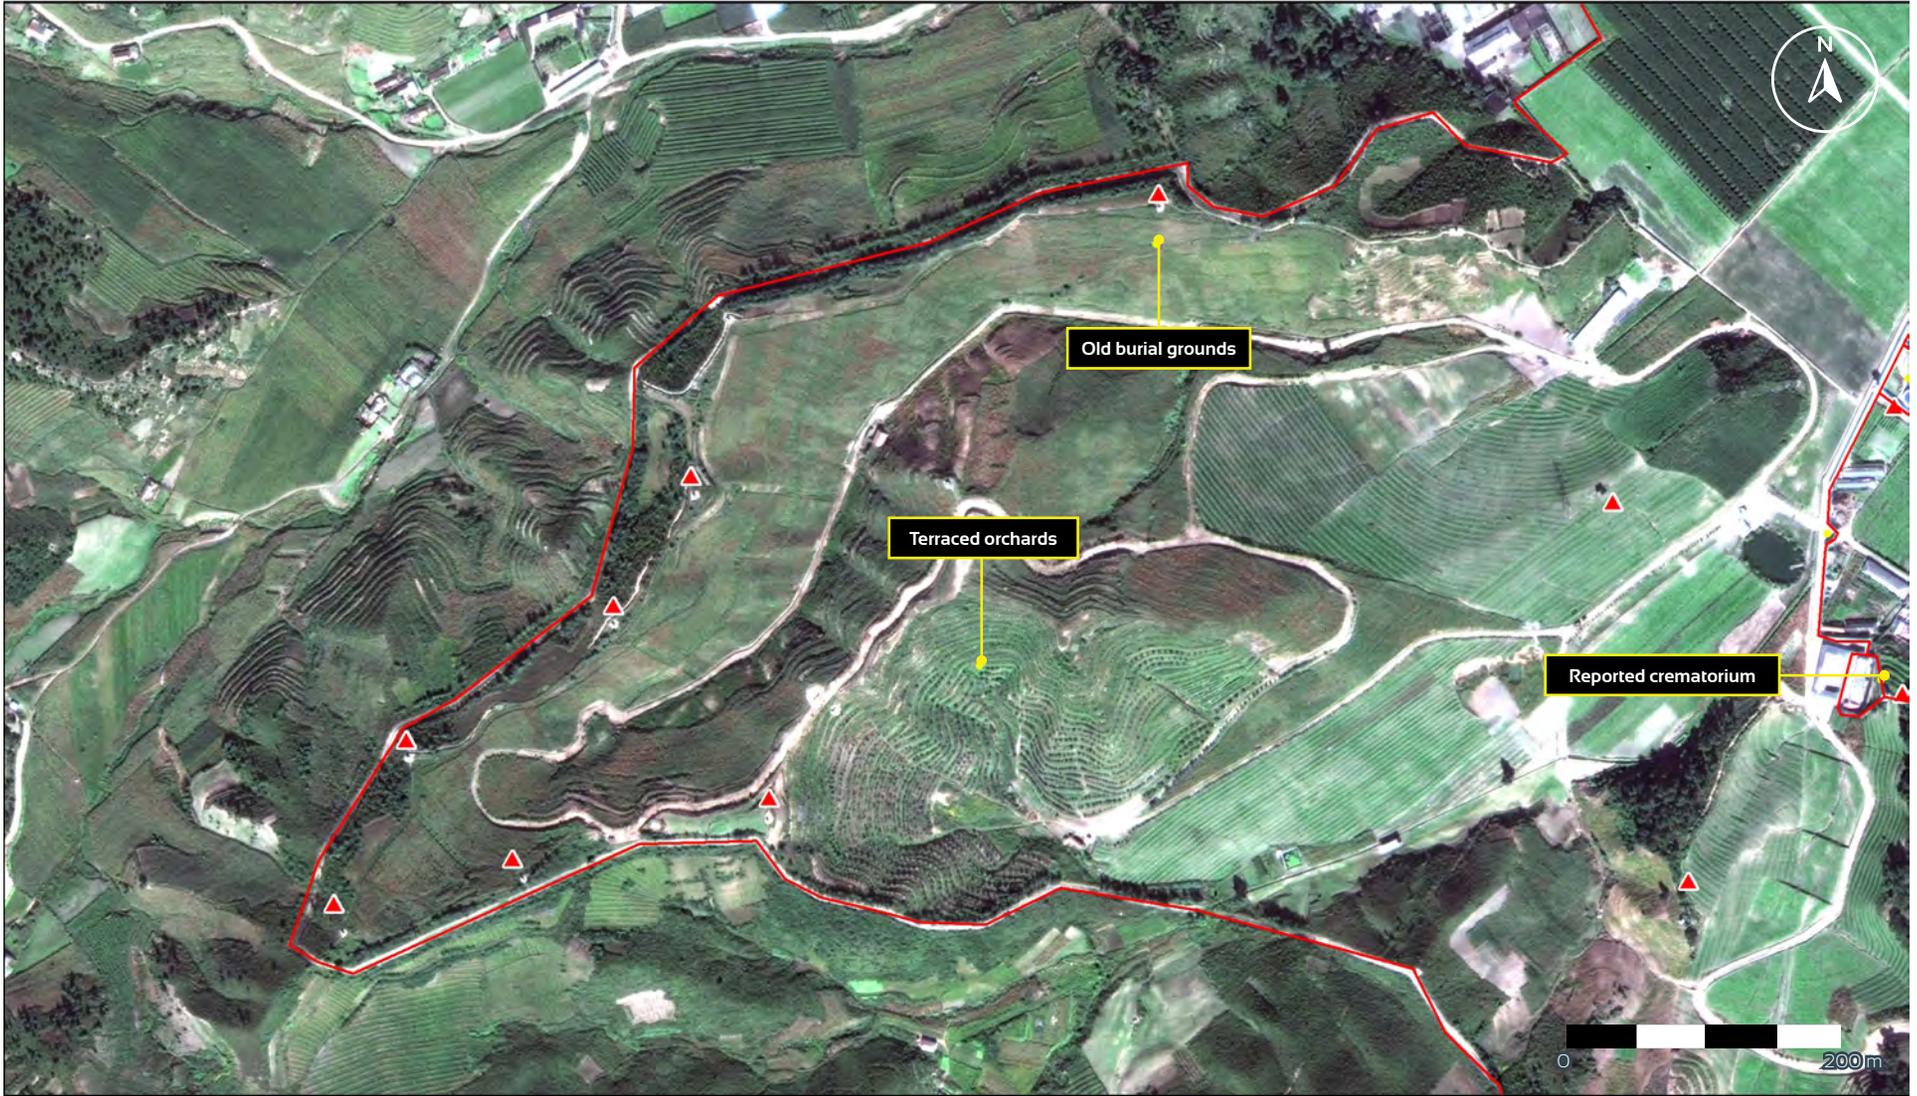
Figure 21

Western Agricultural Area, September 21, 2015. (41.832 N, 129.715 E)

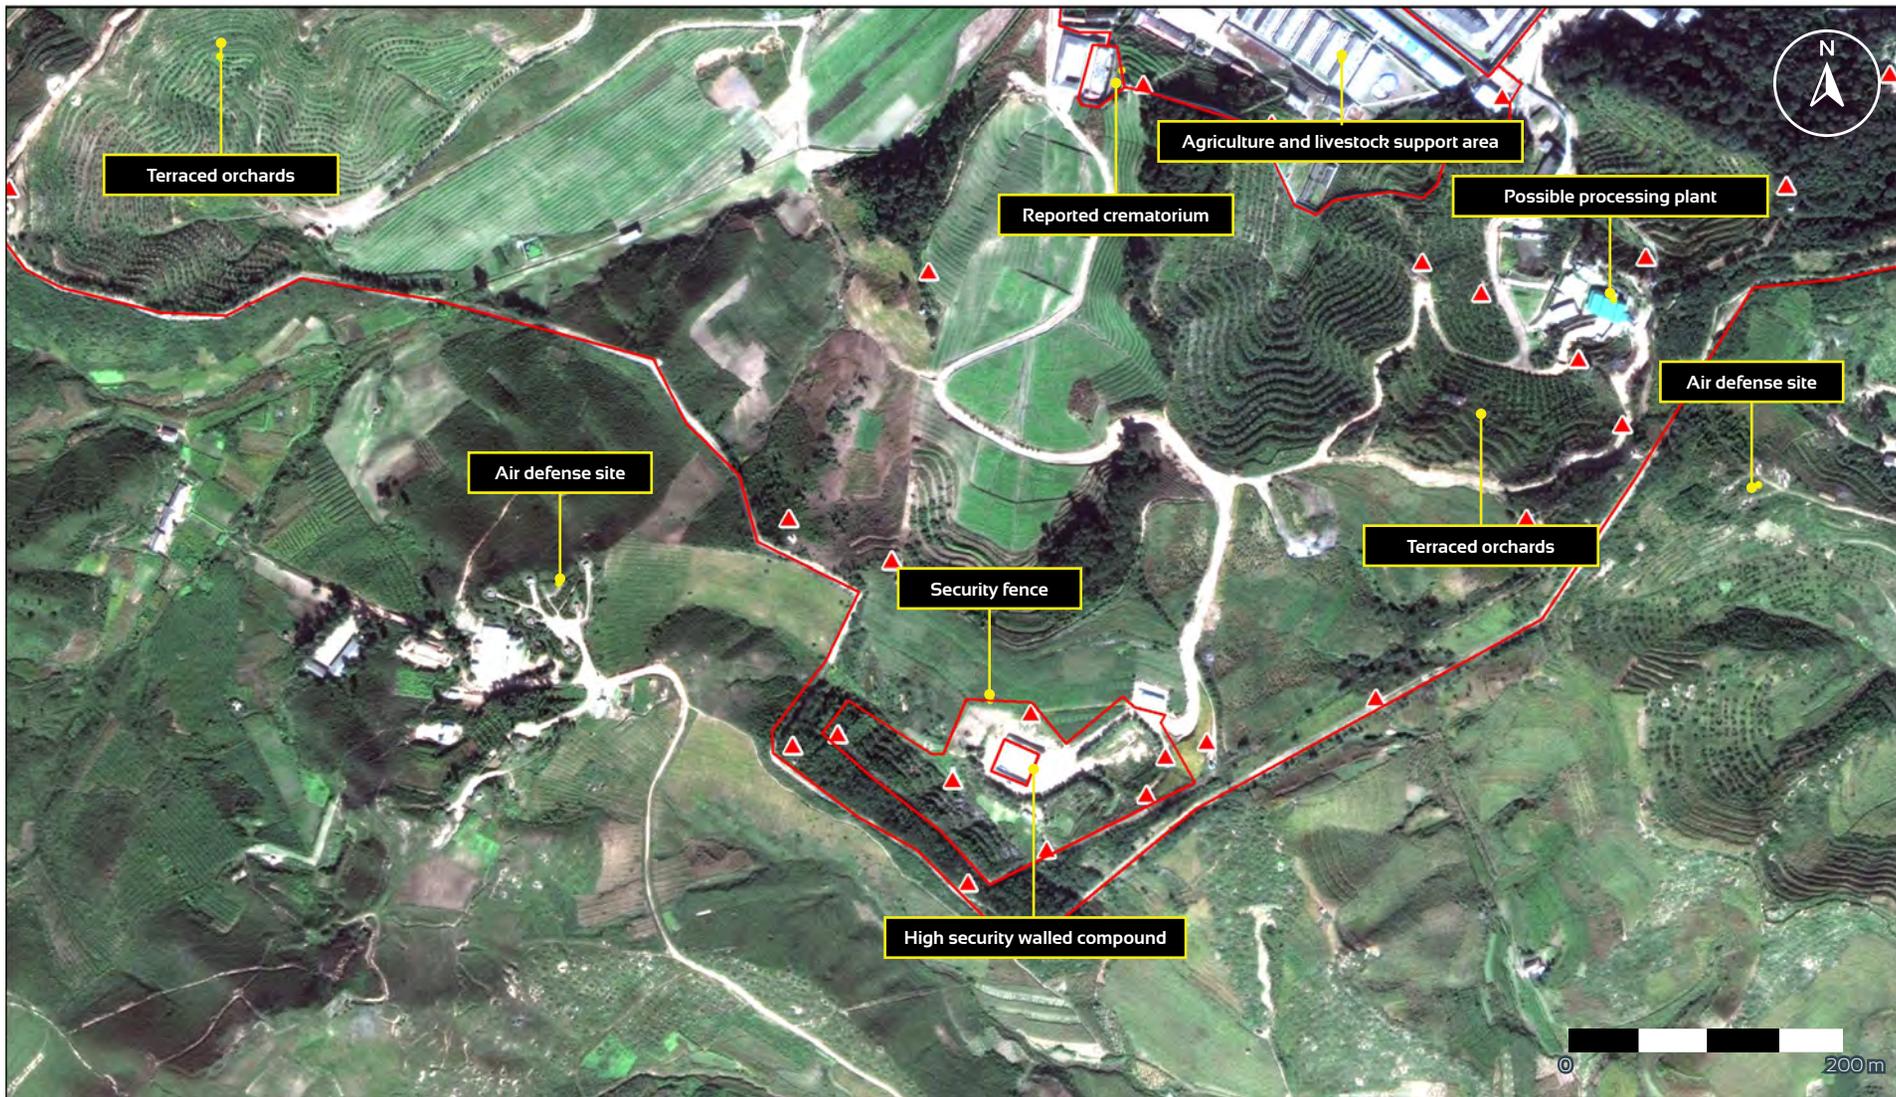
Figure 22

Between May and October 2014, a small facility was built in the center of terraced orchards in the southern agricultural area (Figure 22). This facility is approximately 100 meters (109 yards) from the central walled compound and consists of a retention pond, a small stepped structure built into the side of the hill, and several smaller outbuildings. Although its exact purpose is unknown, it appears to be a processing facility, probably associated with the orchards.

Southern Agricultural Area, September 21, 2015. (41.829 N, 129.722 E)

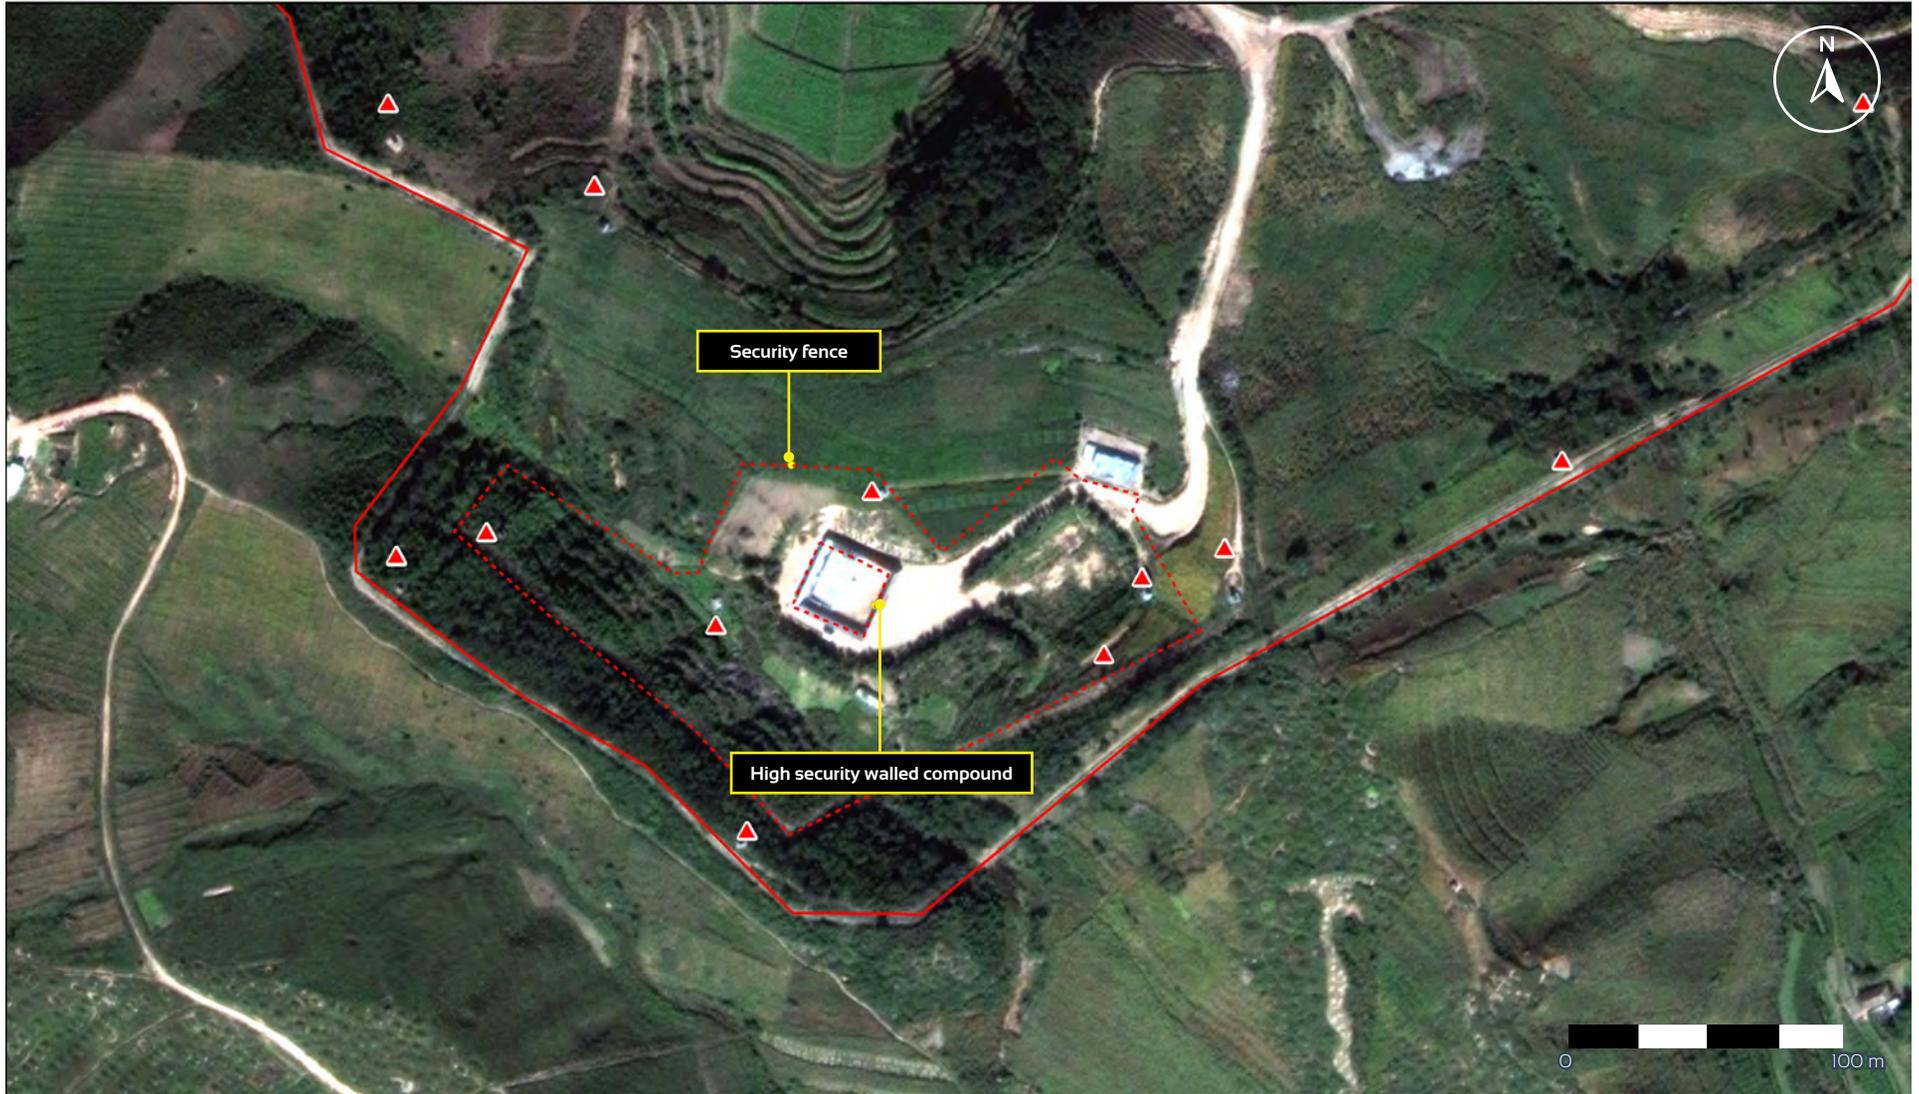
Figure 24

Located within the extreme southwest corner of Camp No. 25's perimeter is a small 25 meter by 25 meter (27 yard by 27 yard) walled compound that was constructed during 2010 (Figure 23, Figure 24). Inside the compound is one

14 meter by 9 meter (15 yard by 9 yard) single-story building. Approximately 100 meters to the east is a 14 meter by 6 meter (15 yard by 6 yard) single-story building. The relative isolation of the walled compound within the camp and the fact that it is overlooked by seven guard positions is strongly suggestive of a high security prison compound as its size and construction are not consistent with DPRK practices for the storage of heavy equipment or munitions.

Secured Compound, September 21, 2015. (41.828 N, 129.722 E)
