North Korea Camp No. 25 - Update 2

North Korea: Imagery Analysis of Camp No. 25 - Update 2

Susŏng-dong, Ch'ŏngjin-si,
Hamgyŏng-bukto

August 26, 2016

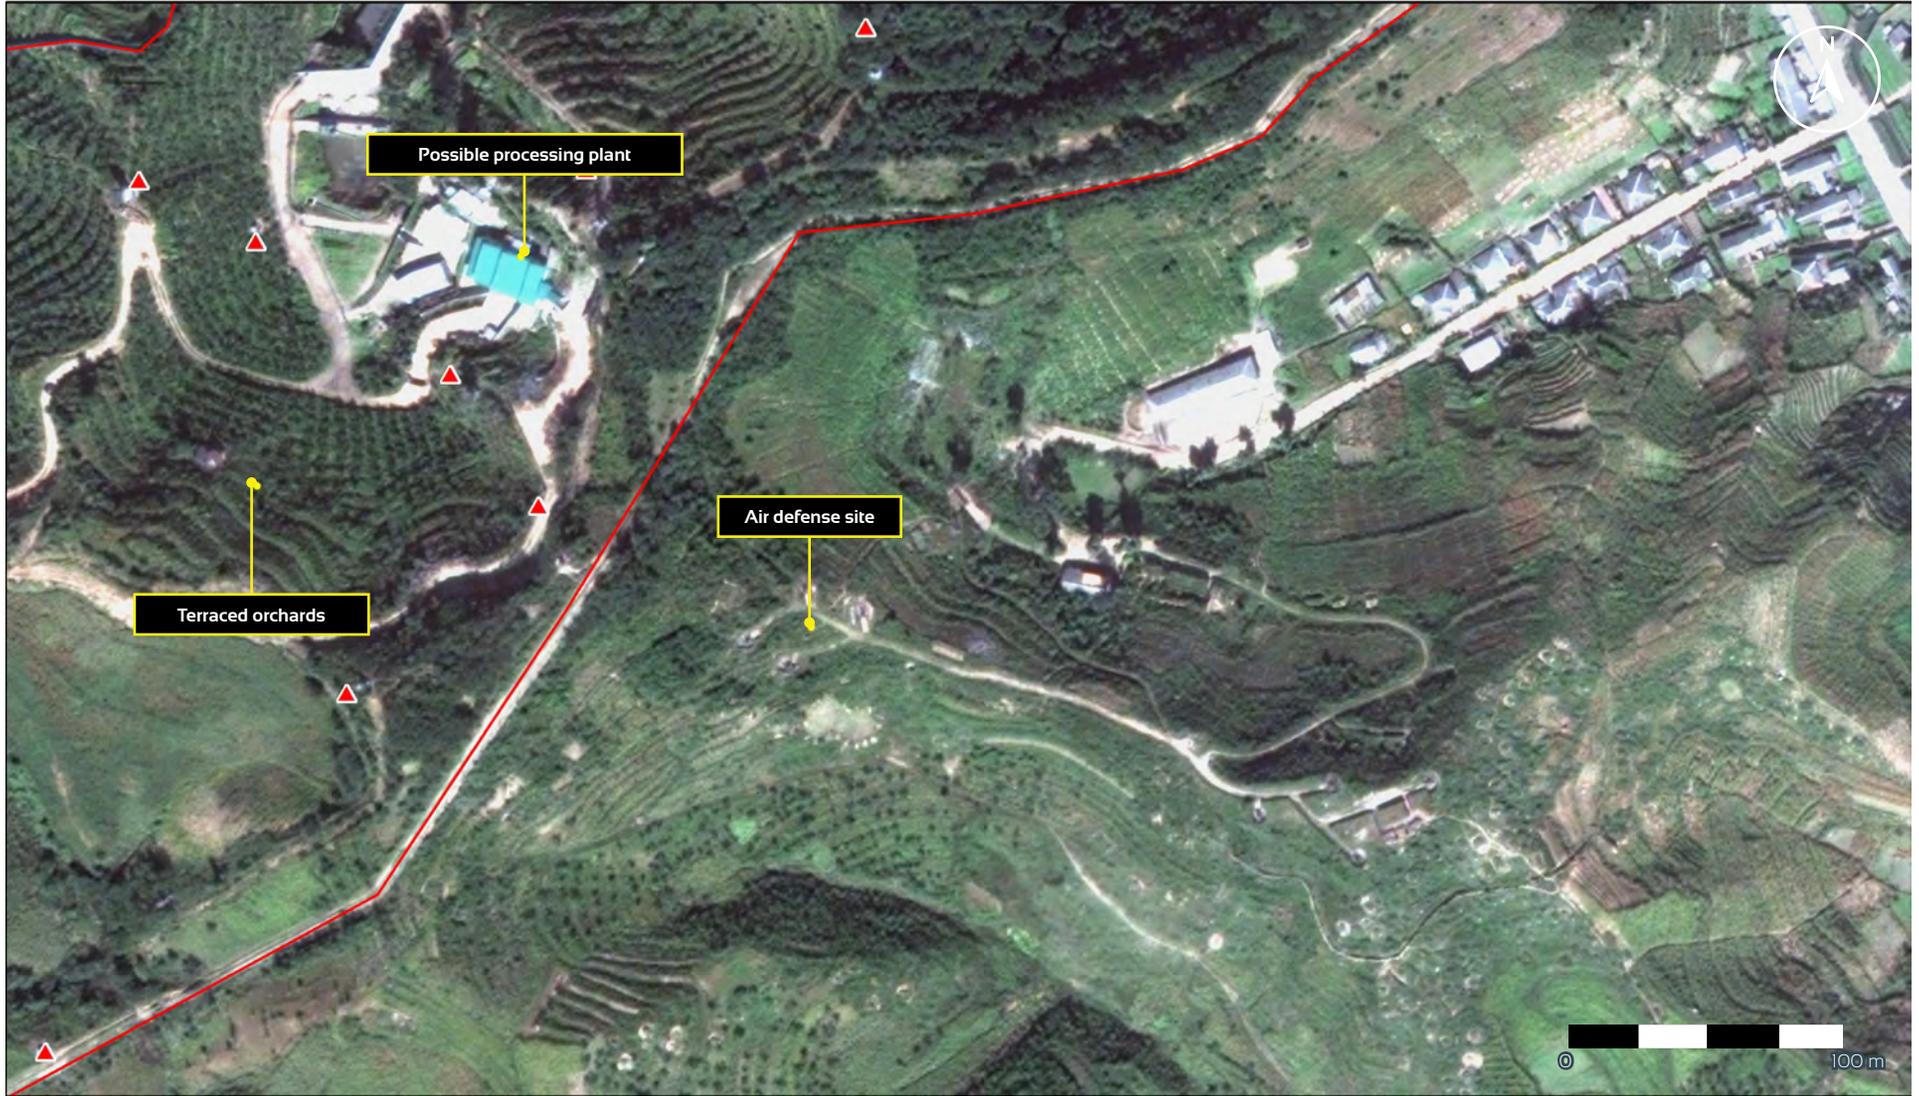
Figure 25

Immediately adjacent to Camp No. 25's perimeter are two air defense artillery sites—one to the west and one to the south (Figure 25, Figure 26). With the expansion of the perimeter in 2010, the southern anti-aircraft artillery (AAA) site, consisting of a battery of eight light caliber anti-aircraft guns, was removed and its land incorporated into the expanded perimeter. It was replaced by a new AAA site 60 meters to the south of the expanded perimeter. The AAA site to the west consists of a battery of six medium caliber anti-aircraft guns. Both sites consist of headquarters, barracks, and support buildings. Although these are well placed to provide protection to Camp No. 25, they are more likely components of the integrated air defense of Ch'ŏngjin-si.

Southern Air Defense Artillery Site, September 21, 2015. (41.829 N, 129.729 E)
