MAY 29, 2019

North Korea's Long-term Re-education through Labor Camp (*Kyo-hwa-so*) at Pokchŏng-ni

Joseph S. Bermudez, Jr., Greg Scarlatoiu, Amanda Mortwedt Oh, and Rosa Park

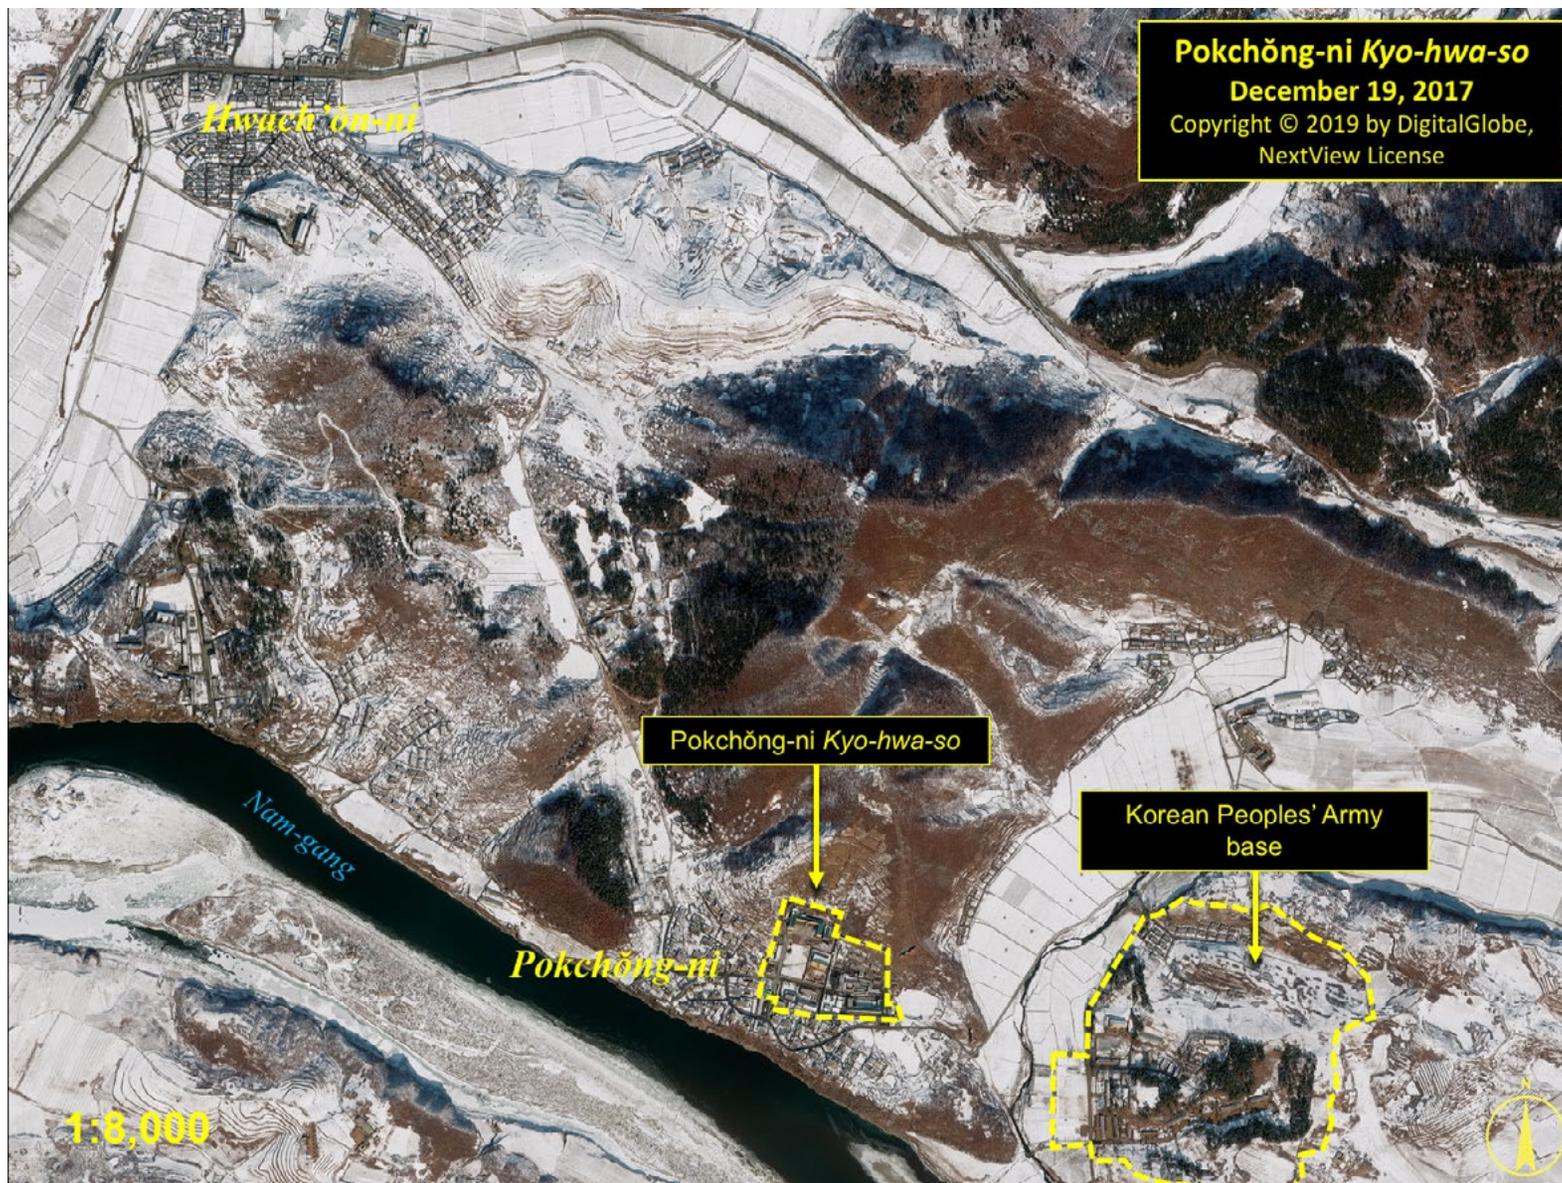
Figure 1

Overview of the Pokchöng-ni *Kyo-hwa-so* and surrounding area, December 19, 2017.

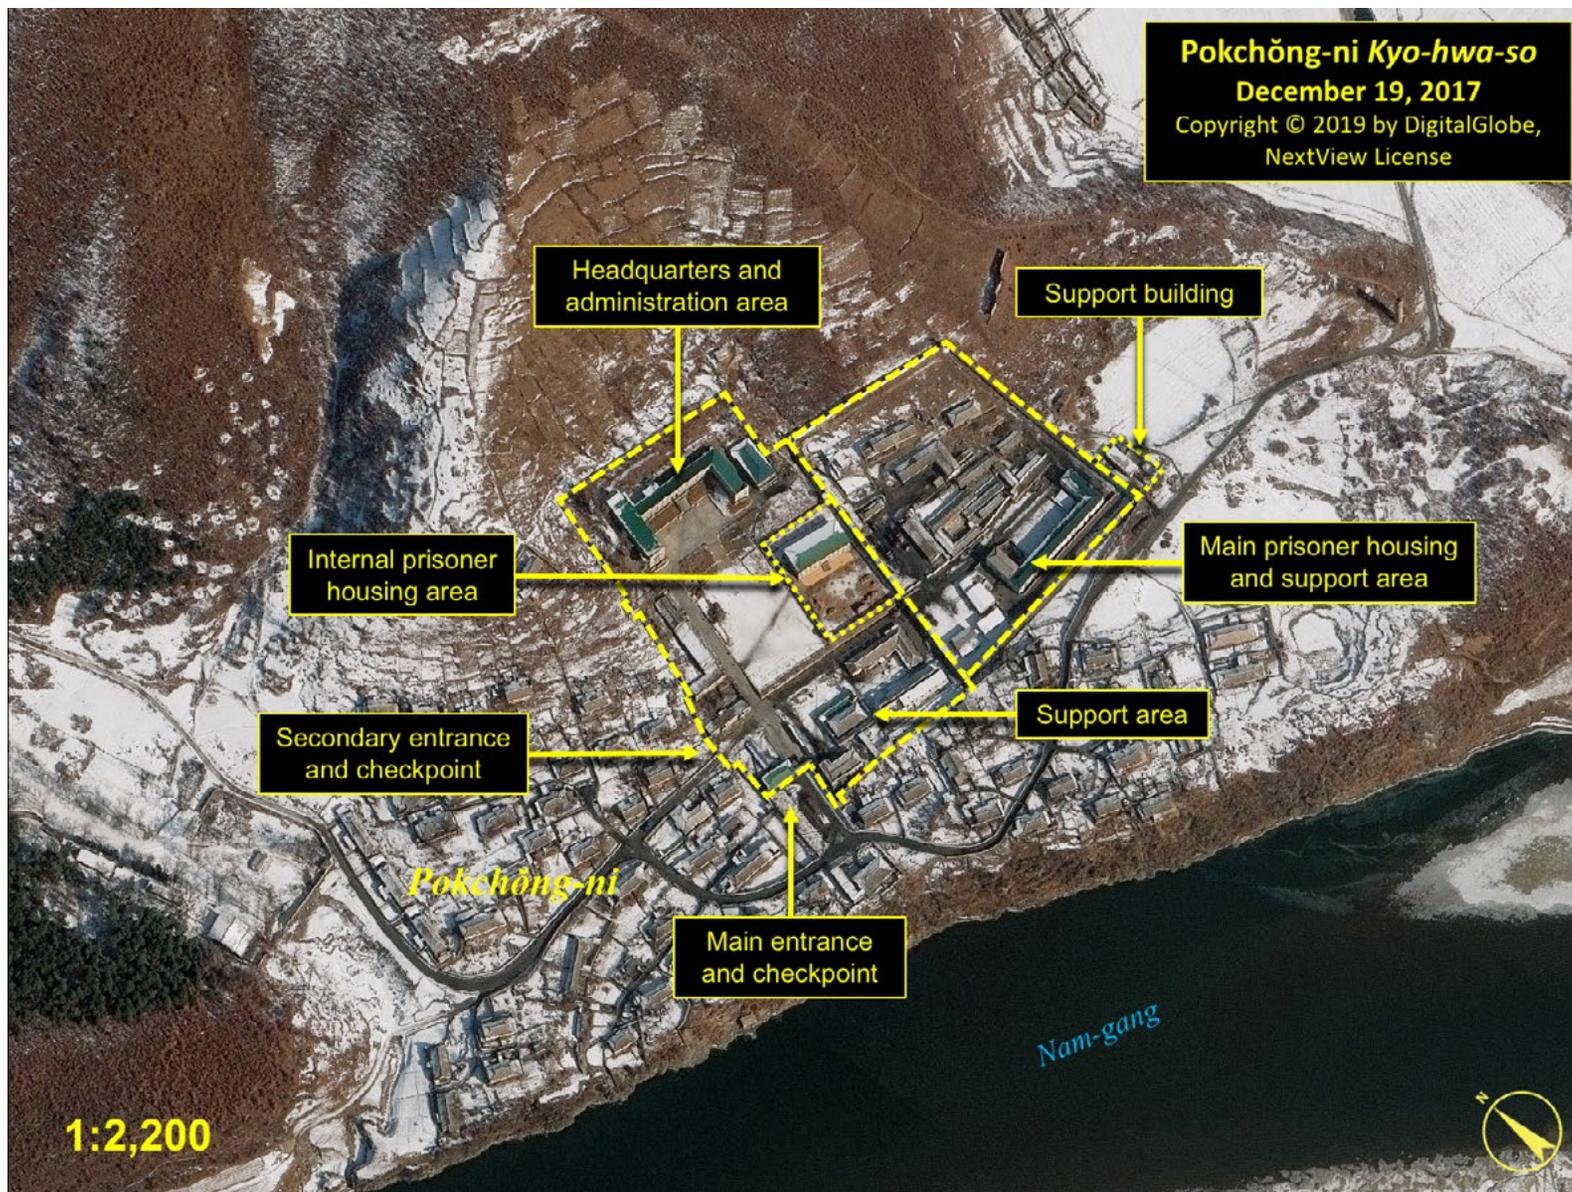
Figure 2

Close-up view of the Pokchŏng-ni Kyo-hwa-so, December 19, 2017.

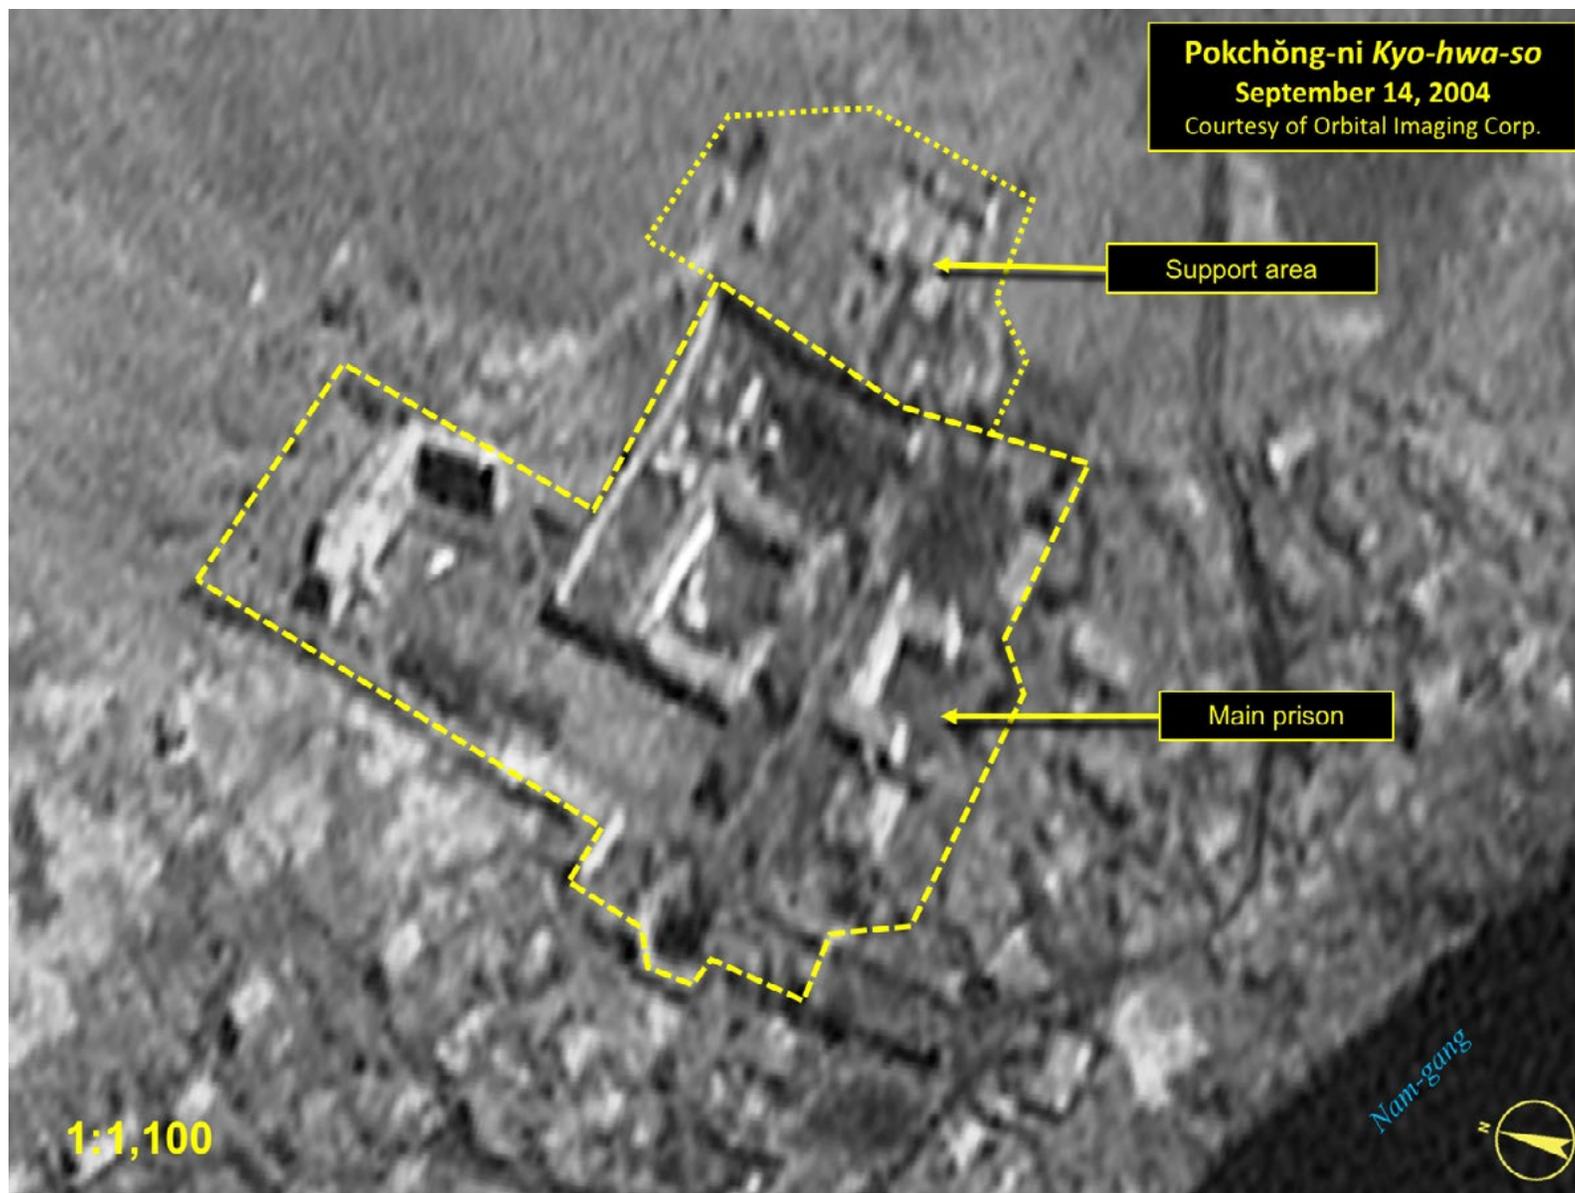
Figure 3

Although of only one-meter resolution, this September 14, 2004 satellite image is one of the earliest to show the Pokchŏng-ni *Kyo-hwa-so*.

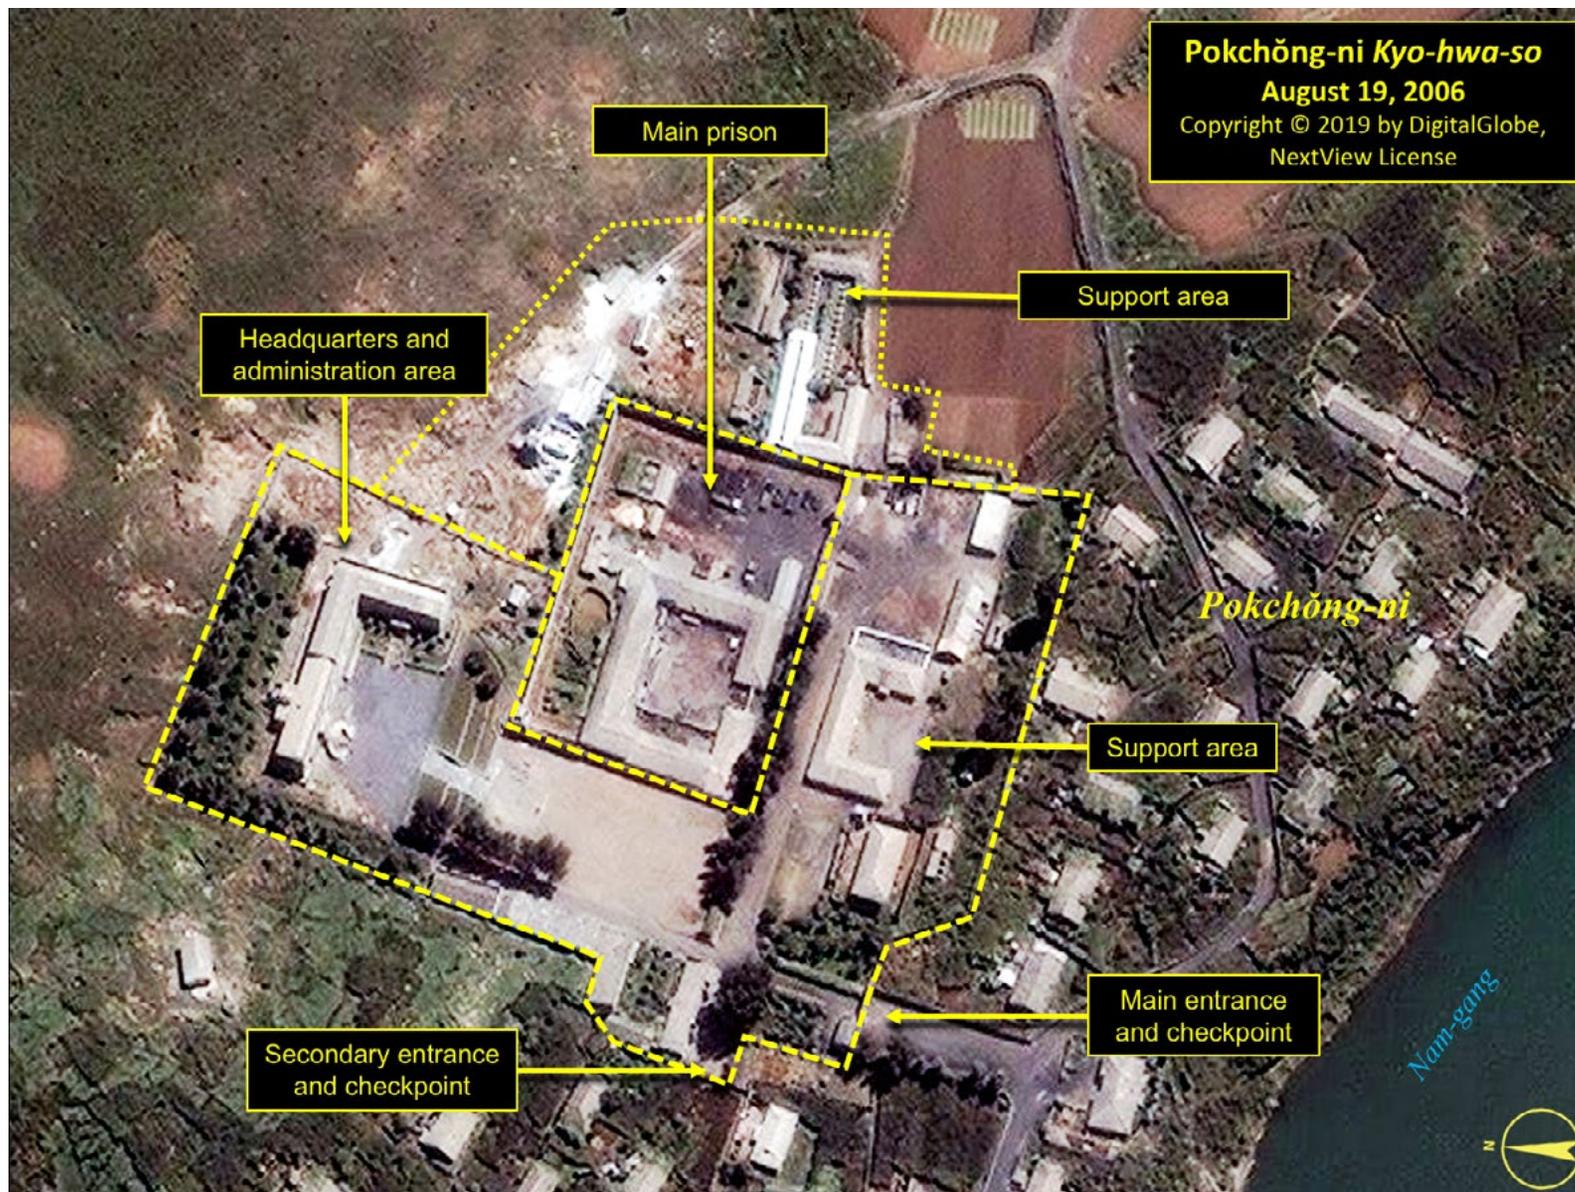
Figure 4

A view of the Pokchŏng-ni *Kyo-hwa-so* on August 19, 2006, showing the general arrangement of the facility before it underwent an expansion during the mid-2000s.

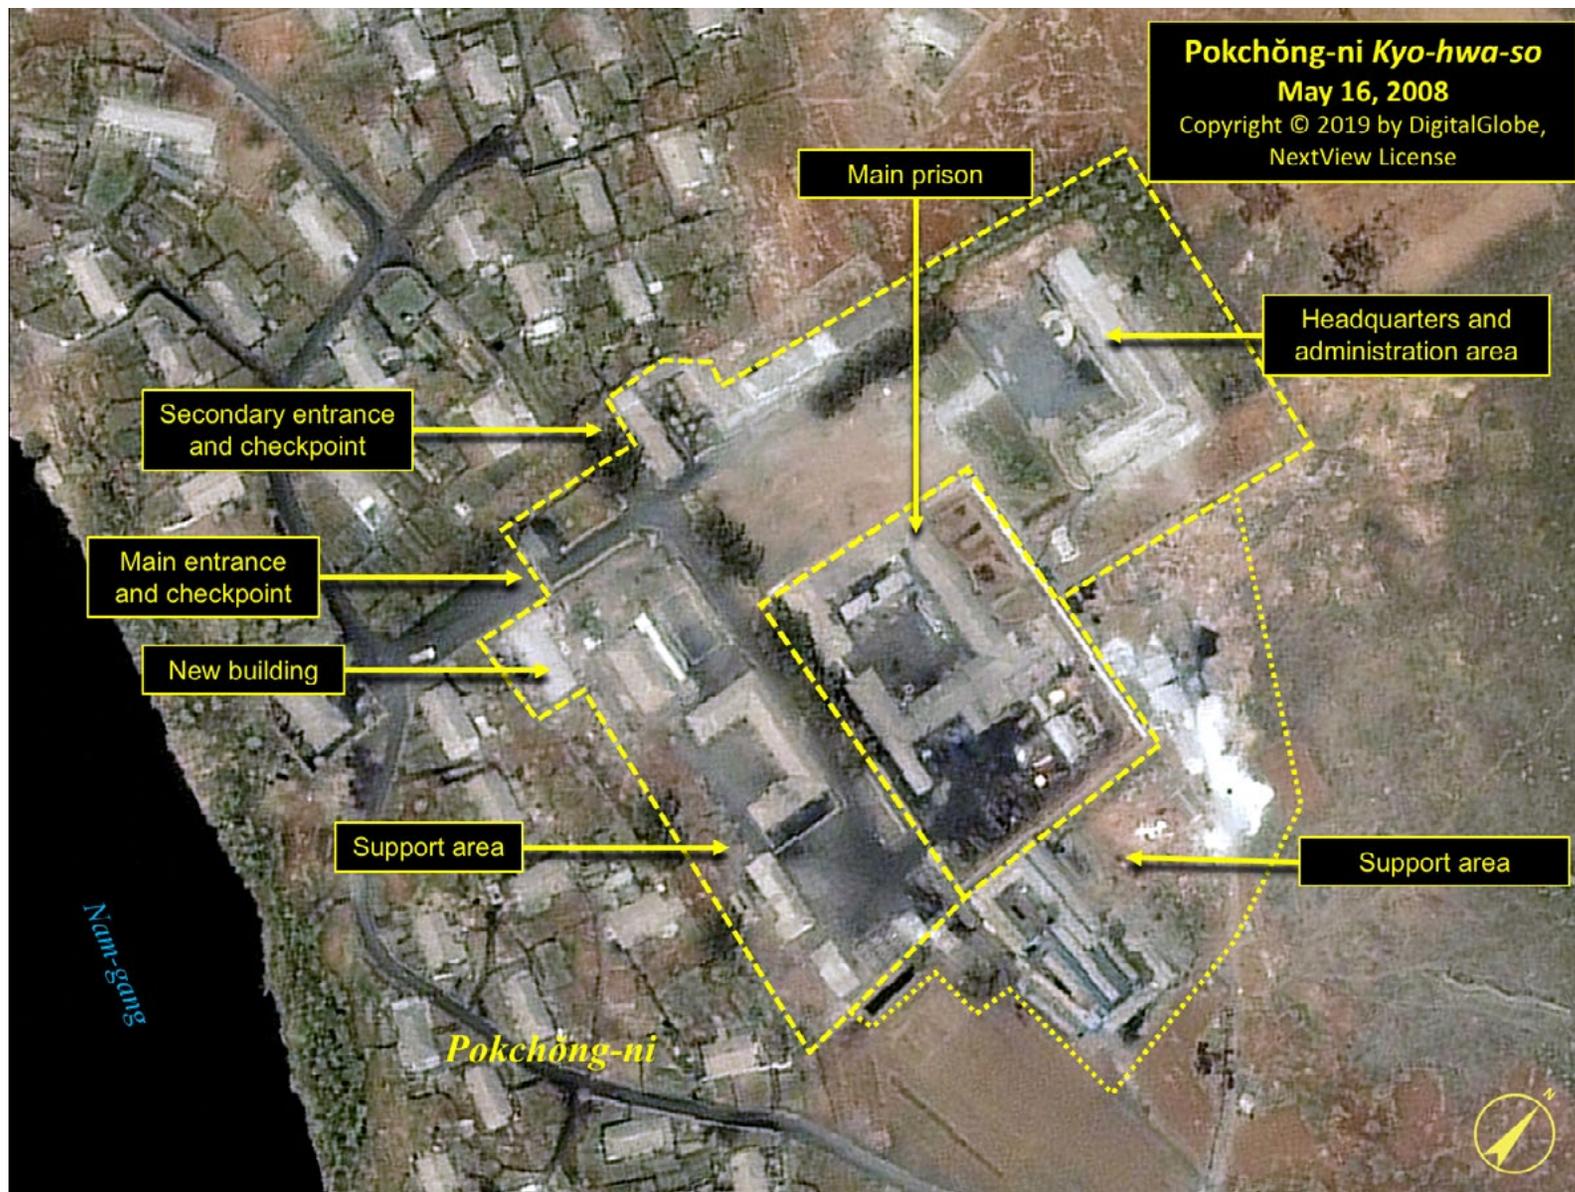
Figure 5

Aside from a new support building no significant changes are noted during the past two years in this May 16, 2008 image.

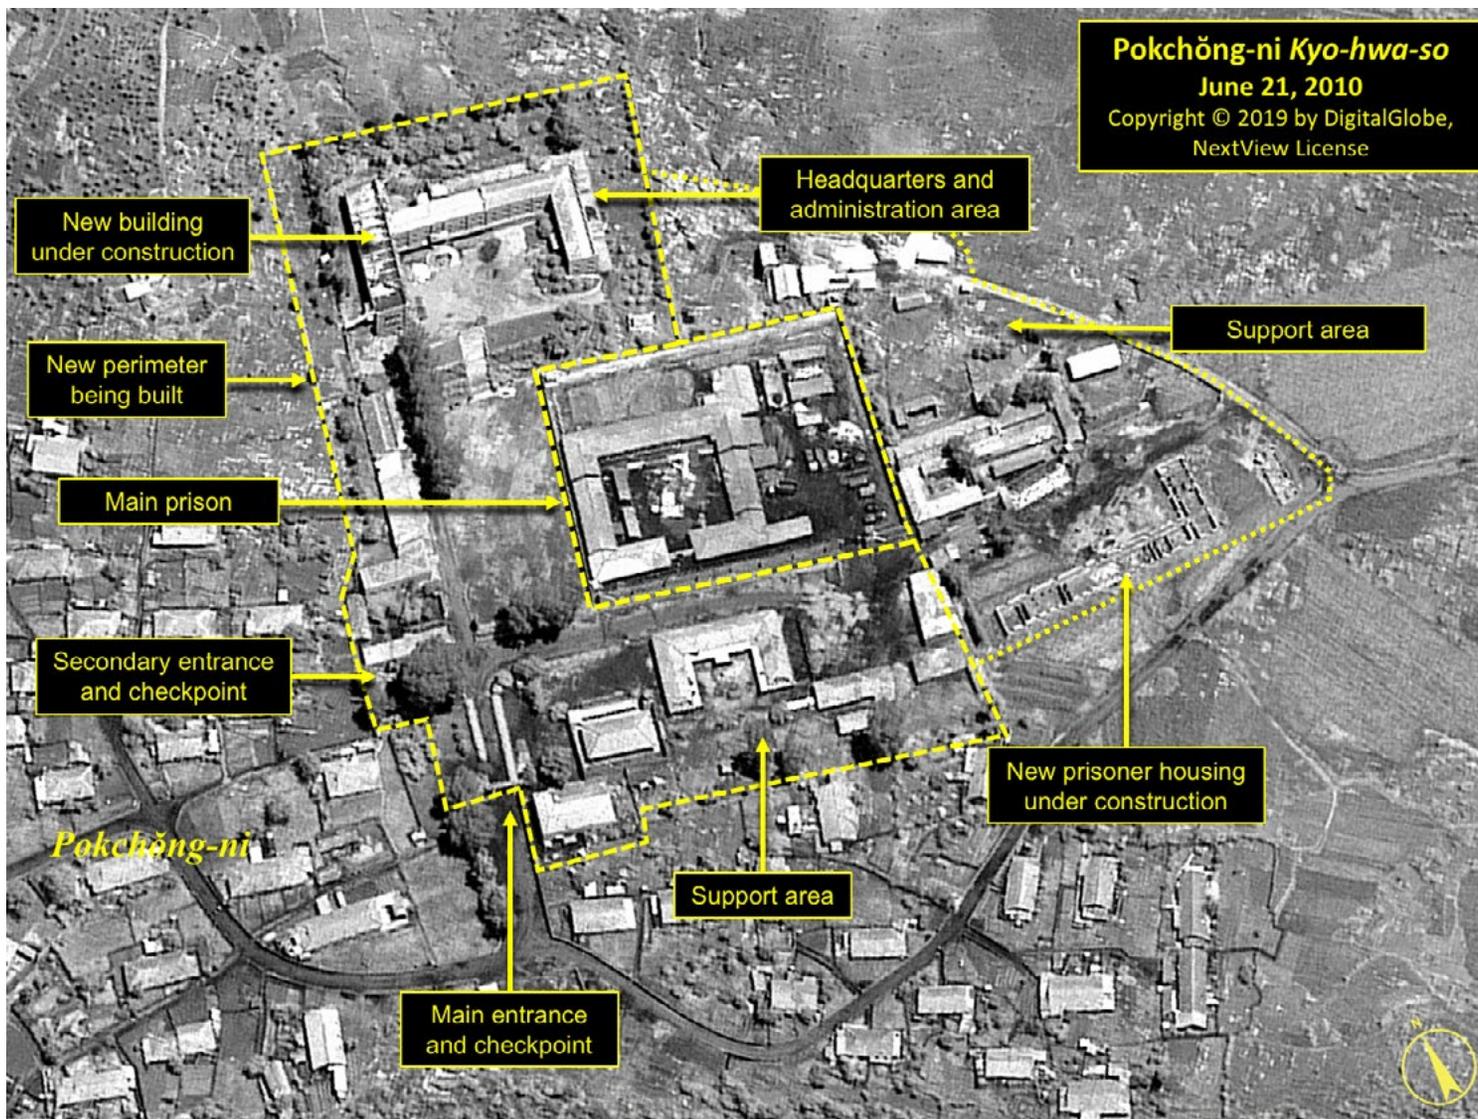
Figure 6

Beginning during 2010, a three-year-long construction project began to expand the prison. In this June 21, 2010 image, a new building is being constructed in the headquarters and administration area, the northwestern perimeter is being expanded, and a new prisoner housing building is under construction on the east side of the facility.

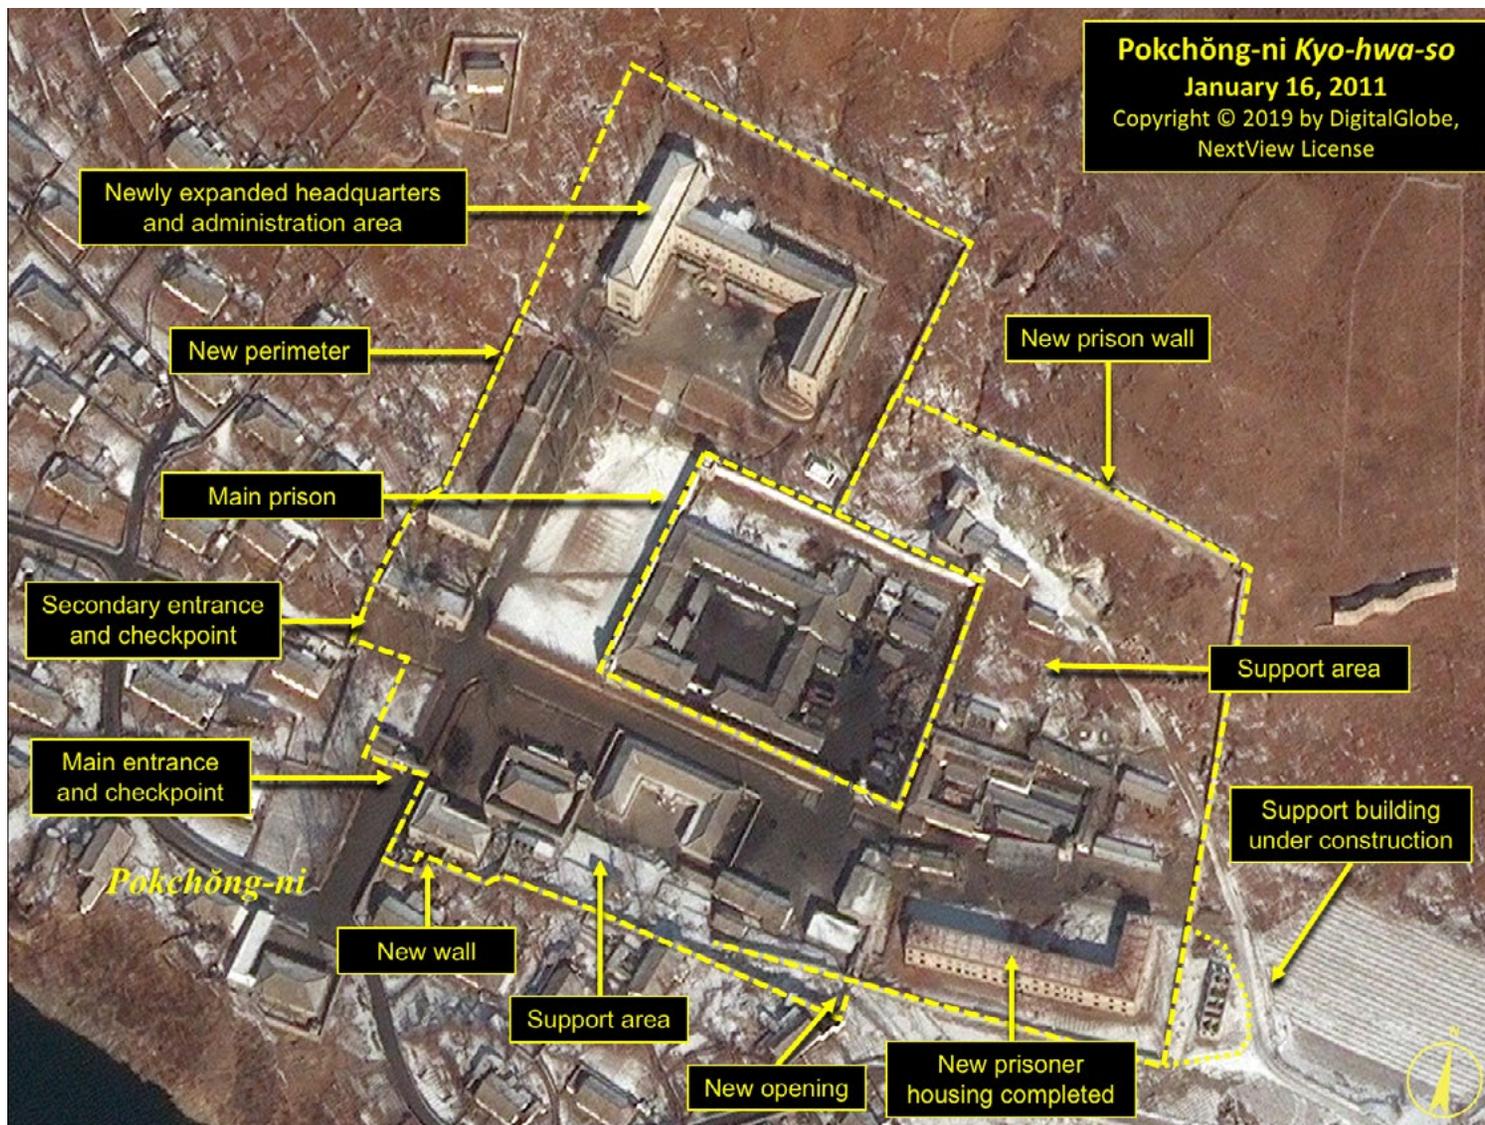
Figure 7

By January 16, 2011, the headquarters, northwest perimeter, and new prisoner housing construction were completed, a new wall on the south side of the facility was erected, and a perimeter wall was extended around the east side of the facility to include the new prisoner housing. A new support building is also under construction outside the southeast corner of the prison wall.

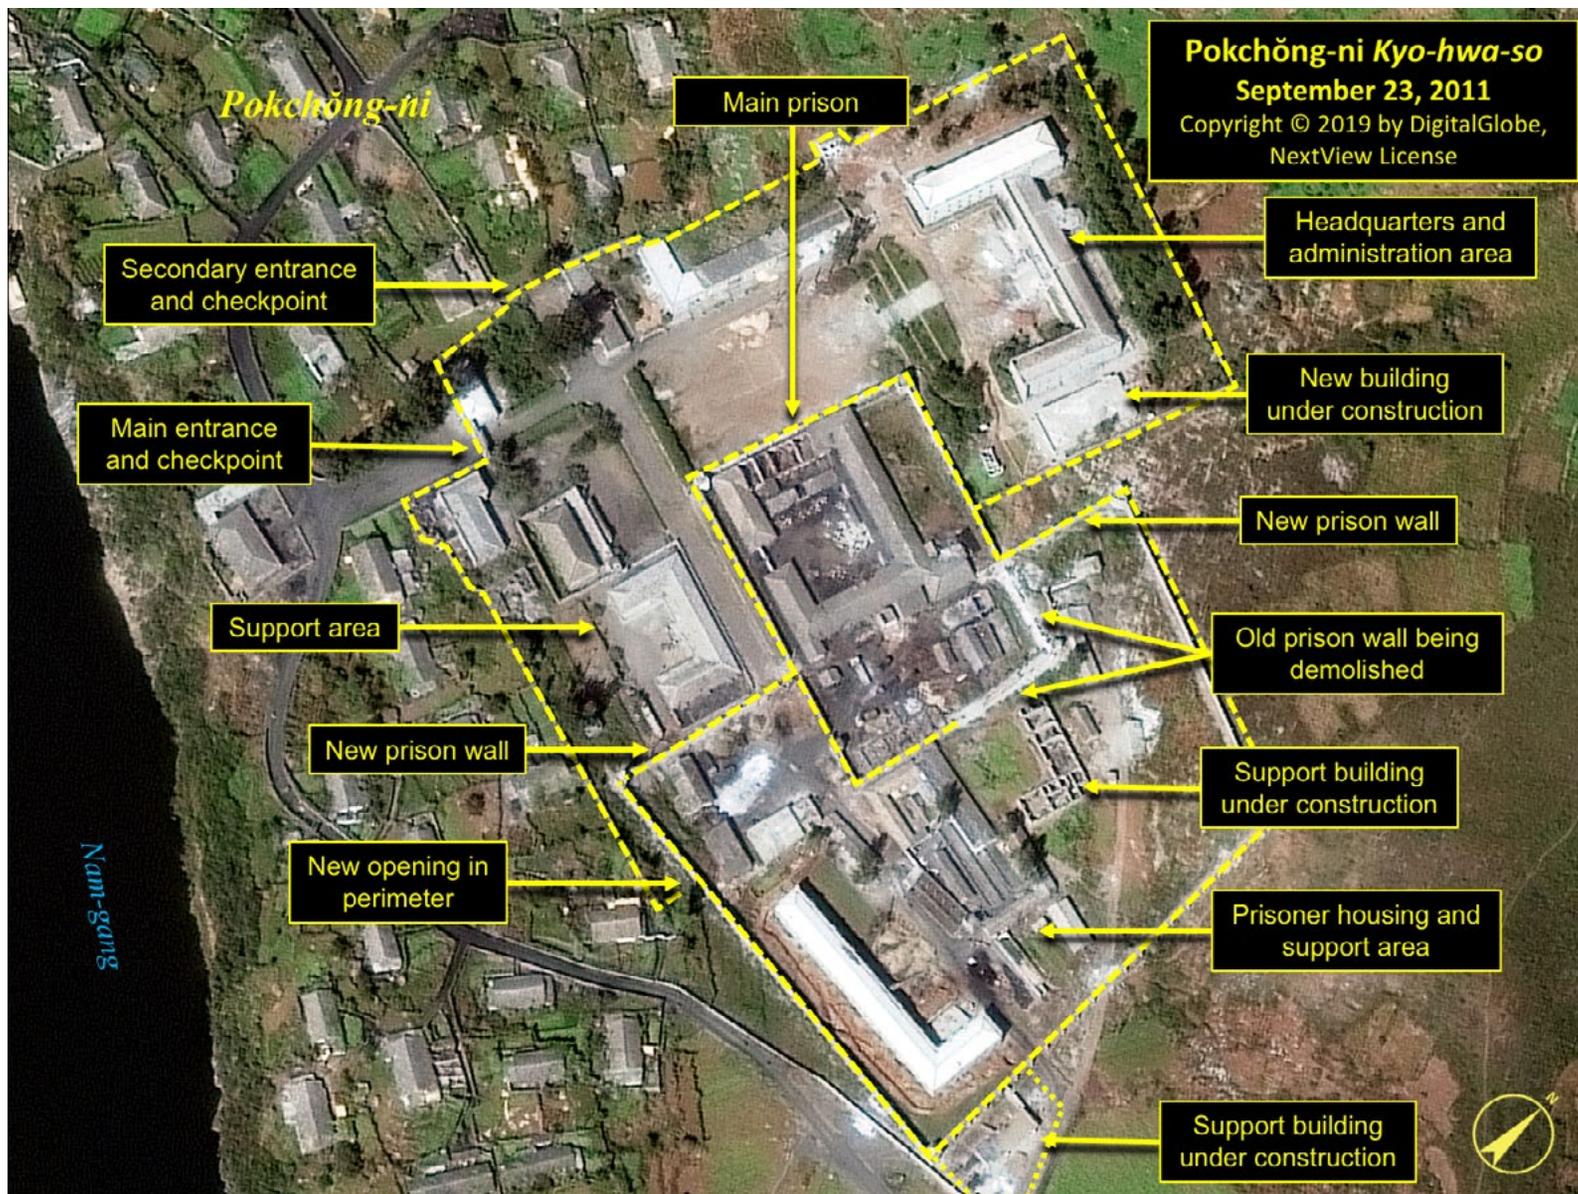
Figure 8

Eight months later, on September 23, 2011, the new perimeter wall was extended into the facility and a new building was under construction in the headquarters area.

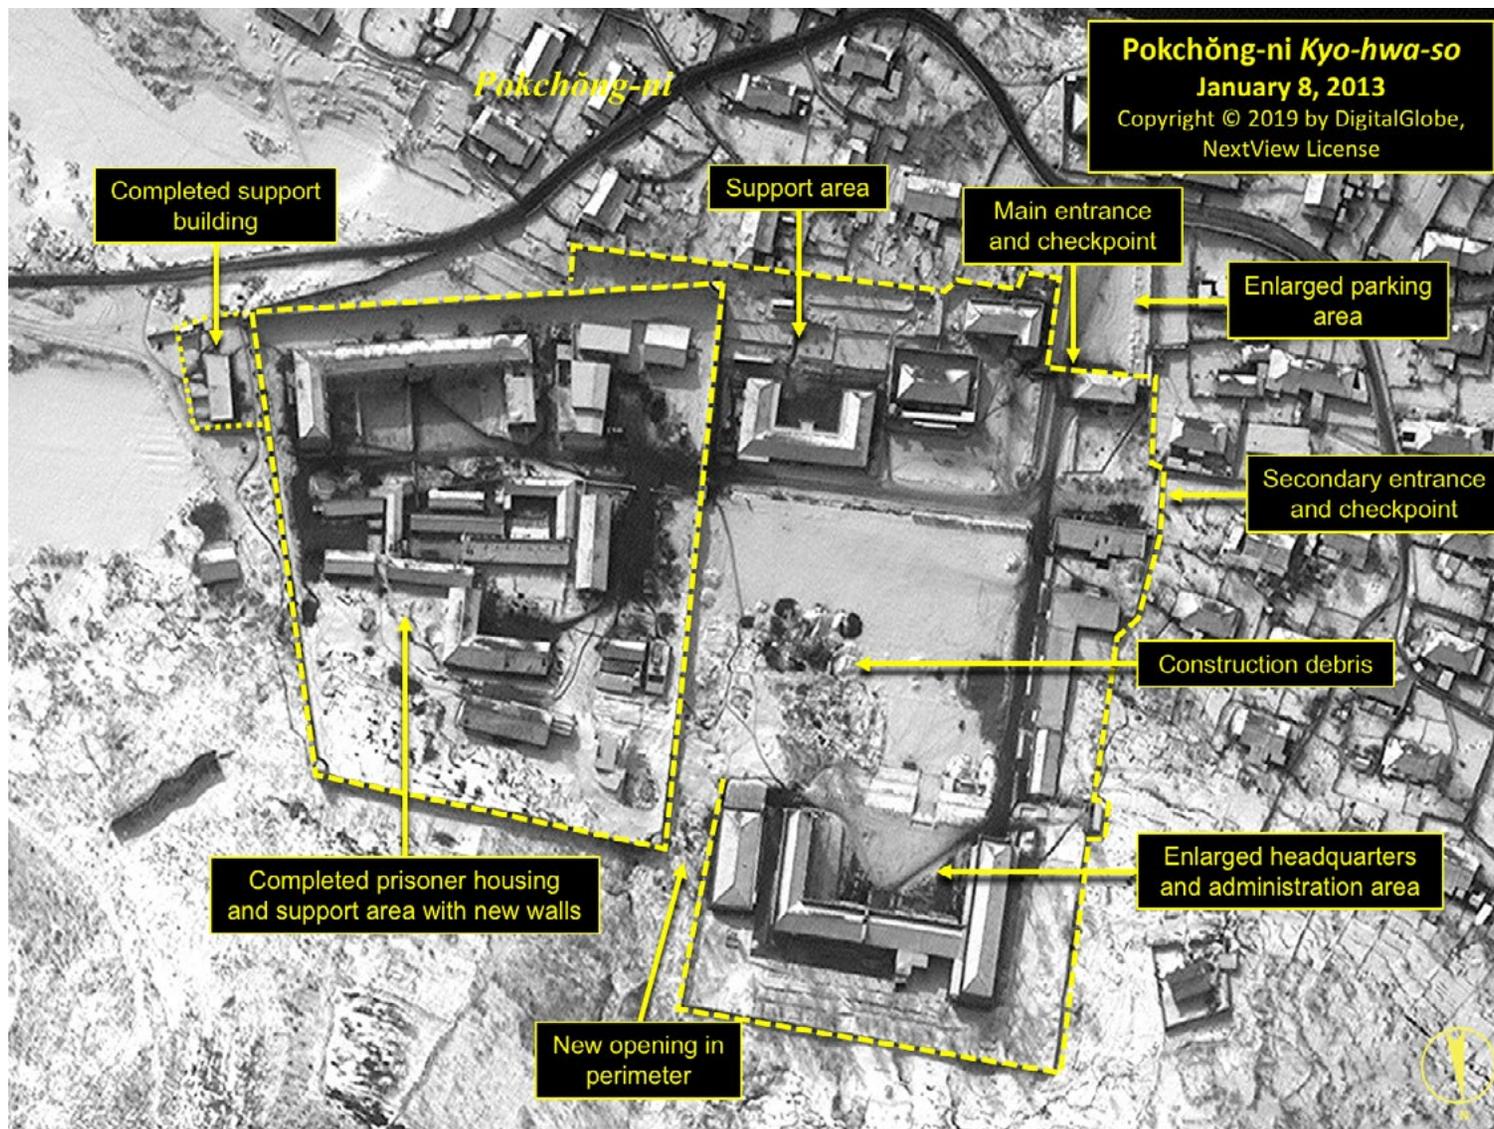
Figure 9

By January 8, 2013, construction of the new prisoner housing and support area was completed and the old prison was razed—construction debris is present at the former site. The headquarters construction was complete as was the new support building in the southeast corner of the facility. Accompanying these changes, the parking area in front of the main gate was expanded.

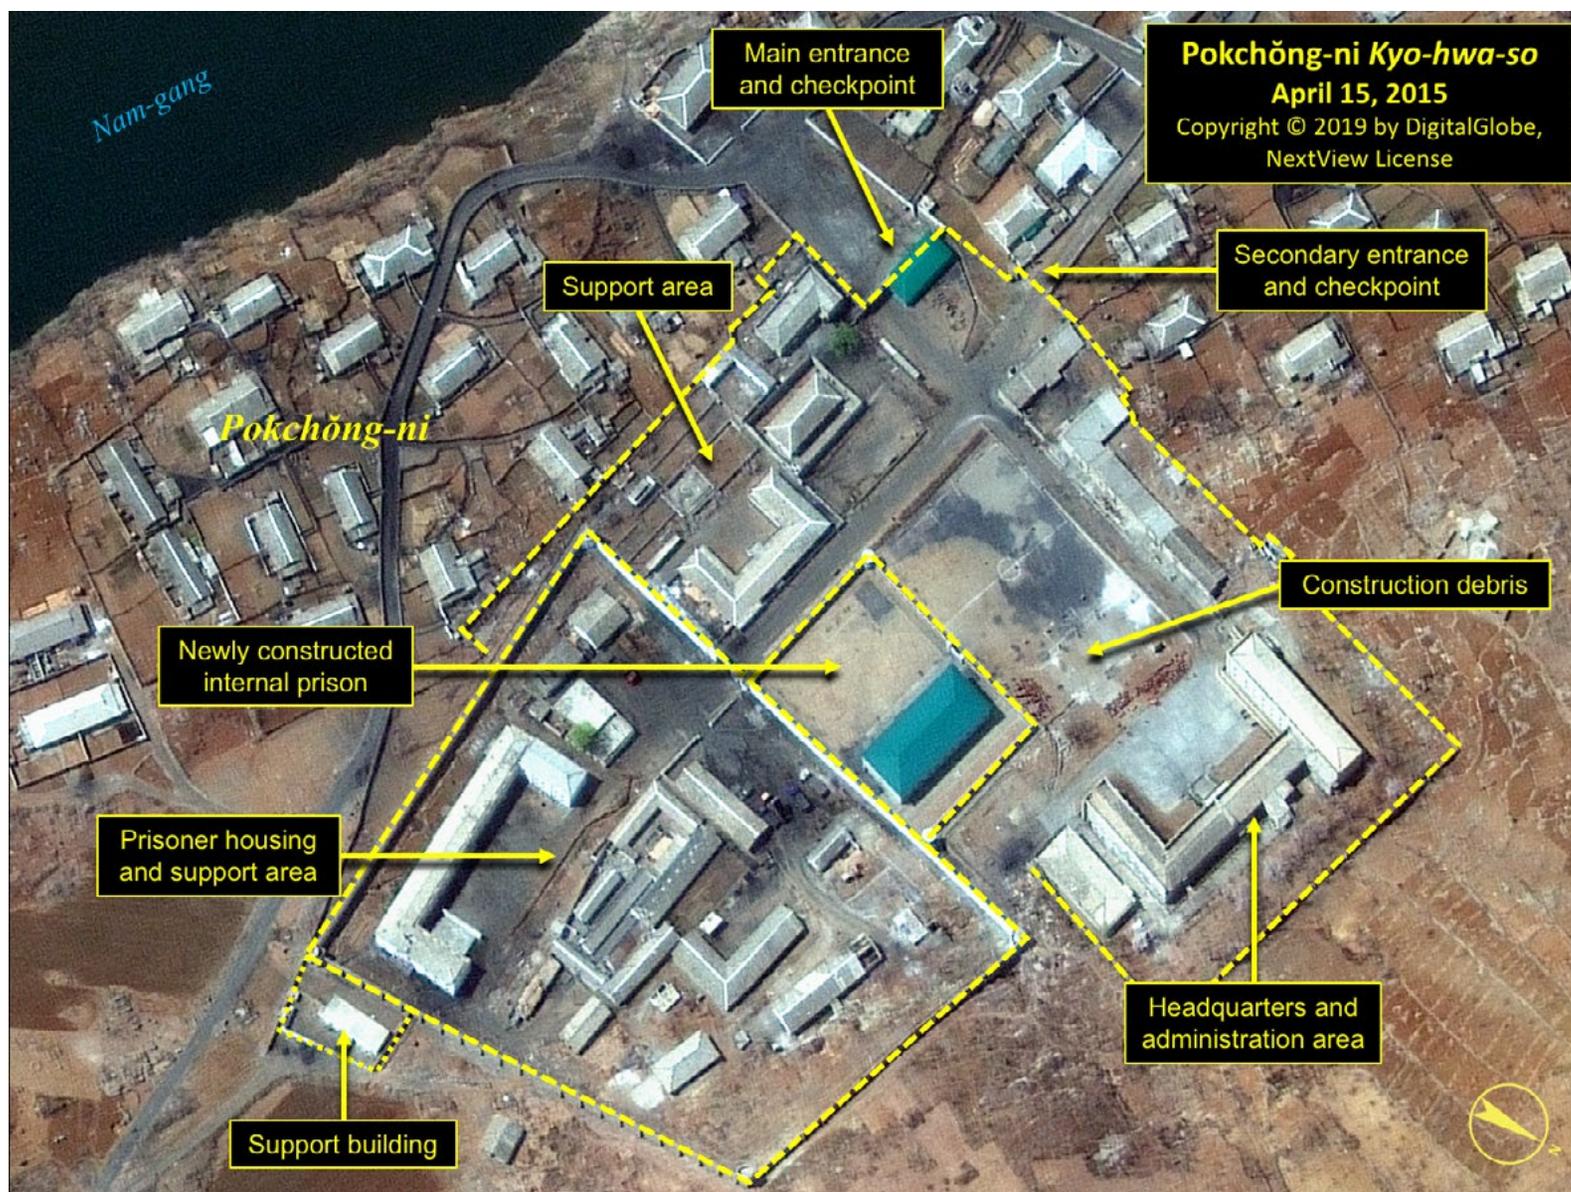
Figure 10

Imagery from April 15, 2015 shows a dramatic change with the construction of a new internal prison that is separated by walls and a gate from the rest of the camp.

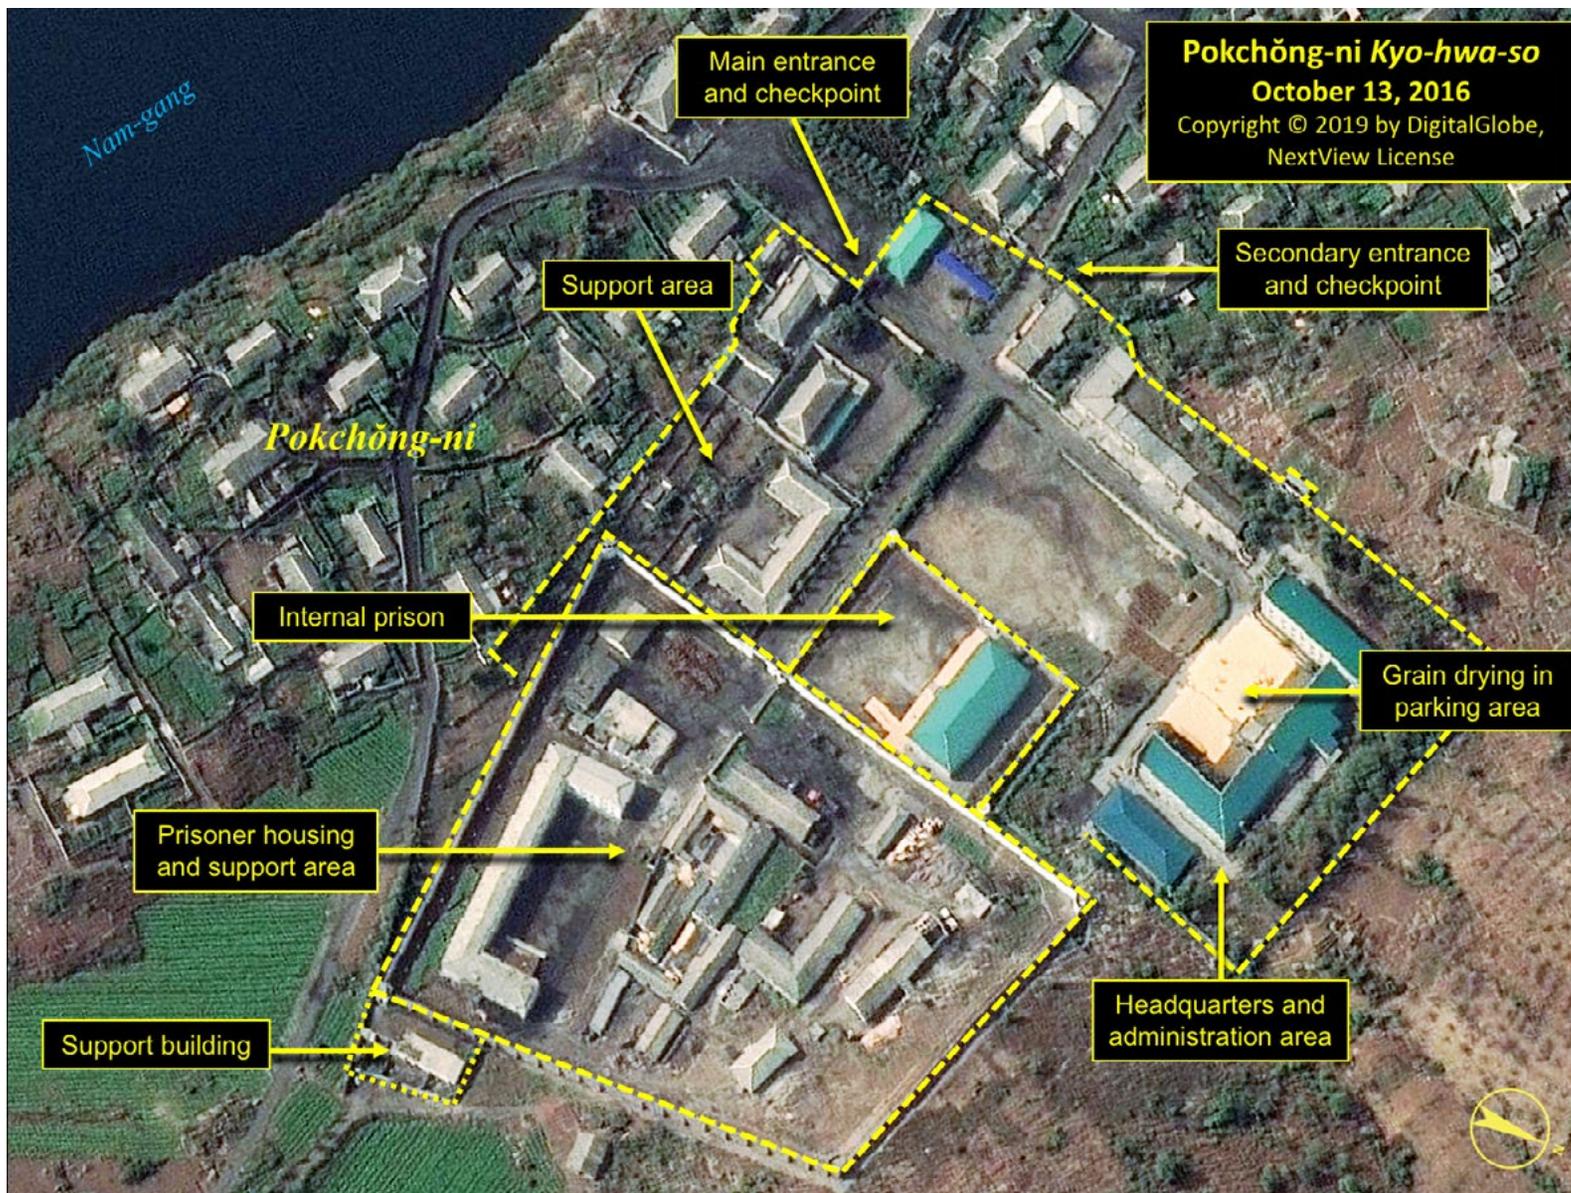
Figure 11

By October 13, 2016, satellite imagery shows that construction has been completed and as of December 19, 2017, retains the same general layout.

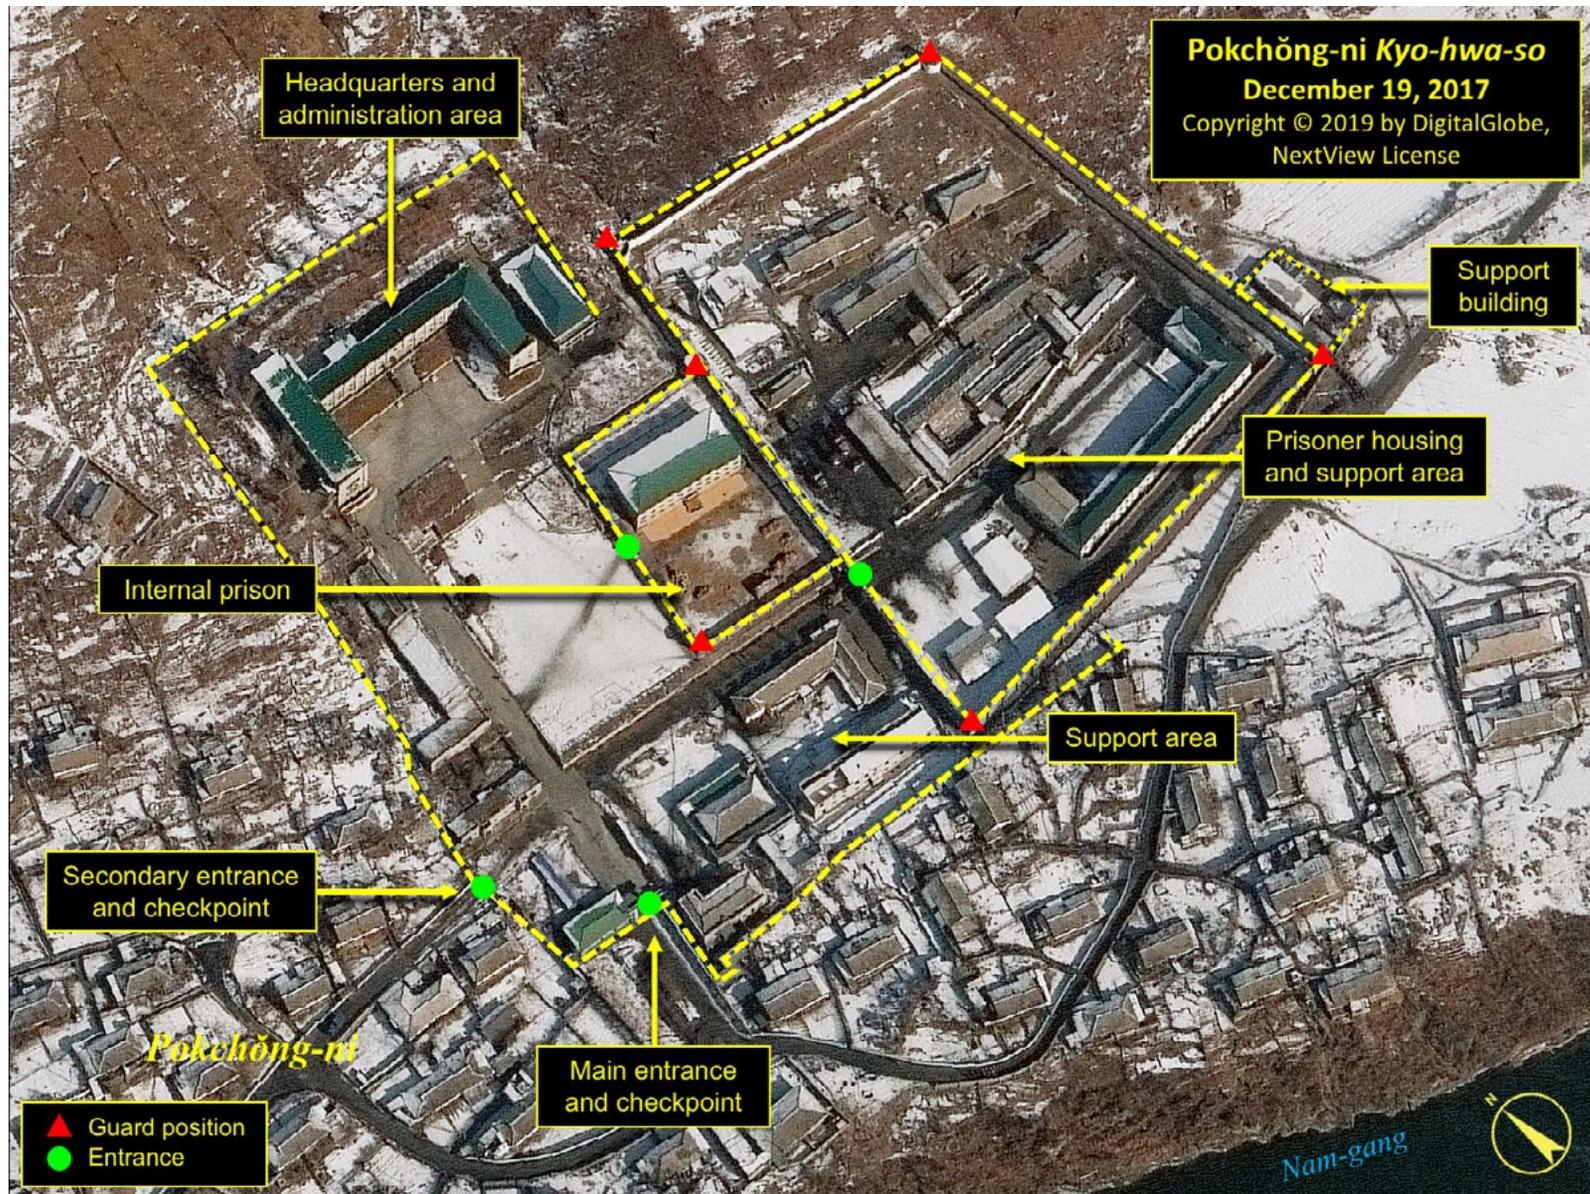
Figure 12

The external perimeter is approximately 955-meters-long (1,044-yards-long) and encompasses approximately 43,848 square meters (52,440 square yards). As of the 2010–2013 expansion project, this perimeter is no longer continuous due to a 14-meter-wide opening that was created on the north side of the camp adjacent to the administration and headquarters area, and a second ten-meter-wide opening is present on the east side of the southern support area wall. The opening on the north side leads to a small building and an orchard

planted on the hillside above the prison. In addition to this opening, the prison has two interior entrances and two exterior guard entrances/checkpoints. One interior checkpoint/entrance separates the main prisoner housing and work area from the rest of the camp, while the second separates the main camp from the new and smaller internal prisoner housing compound. The primary facility entrance/checkpoint sits astride the main road leading into the camp from the south, while the secondary entrance on the west side sits astride the road leading from the housing area.

A total of six guard positions are distributed atop the prison's walls—four on the corners of the main prisoner housing area and two on opposite corners of the

smaller prisoner housing compound (one of these is shared with the main prisoner housing area).

All walls and checkpoints/entrances appear to be well maintained and in good repair. The guard positions are well placed to provide overlapping fields-of-view of the camp and appear to be well maintained and in good repair.

An overview of the Pokchŏng-ni Kyo-hwa-so on December 19, 2017 (the last date for which there is available imagery) with the main prisoner housing and support area, internal prison, four entrances, and six guard towers.
