MAY 29, 2019

North Korea's Long-term Re-education through Labor Camp (*Kyo-hwa-so*) at Pokchŏng-ni

Joseph S. Bermudez, Jr., Greg Scarlatoiu, Amanda Mortwedt Oh, and Rosa Park

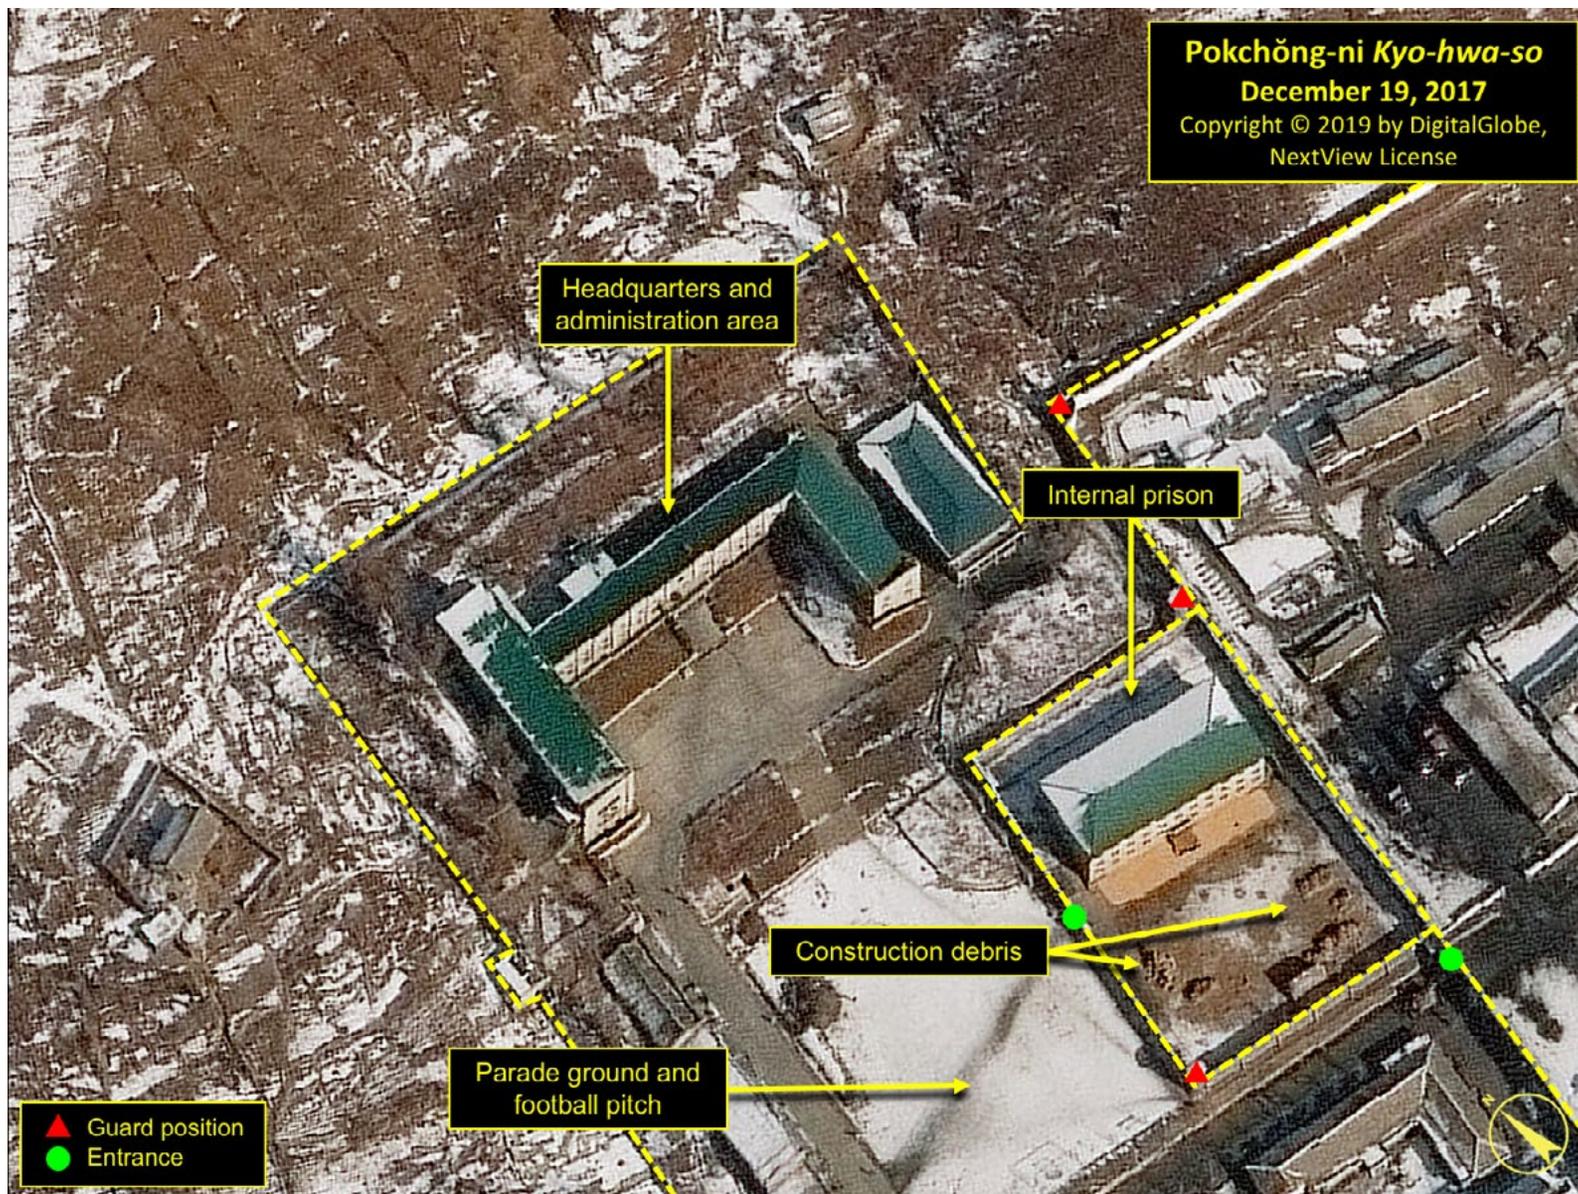
Figure 13

of a large U-shaped two- or three-story building and an adjacent single-story building. In front of the main building is a parking area and an open field—sometimes observed being used by guards and staff as a soccer field.

Immediately south of the headquarters and administrative area is the internal prisoner housing compound. This compound was built between January 8 and October 1, 2013, and measures 65 meters by 45 meters. It has a single entrance and is surrounded by a high concrete wall with two guard positions atop of it (one guard position is shared with the main prisoner housing and work area). Inside the compound is a single 33 meter by 15 meter two- or three-story building. The layout and position of this compound

suggests that it is for a separate class of prisoners, possibly high-value detainees.

A close-up view of the headquarters area and the internal prison on December 19, 2017.

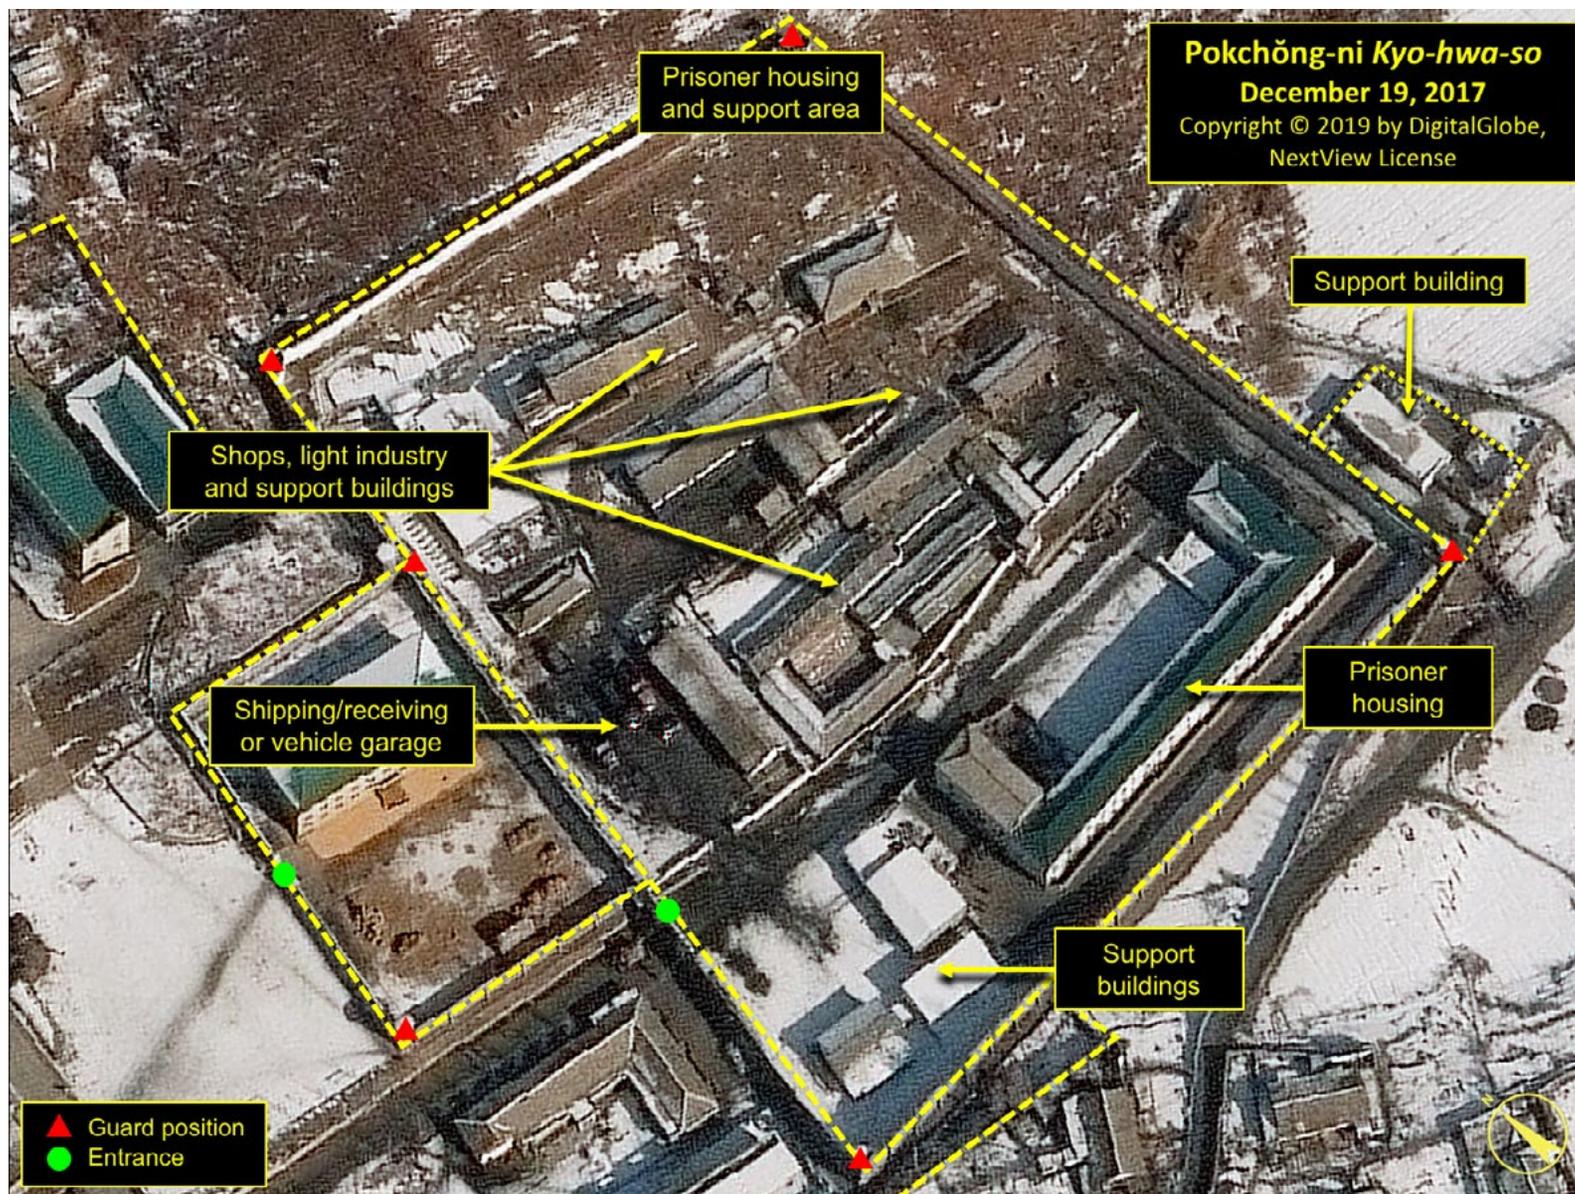
Figure 14

Occupying the east side of the prison is the main prisoner housing and work area. This enclosed area has a single checkpoint/entrance and is surrounded by a high concrete wall with five guard positions atop of it (one of which is shared with the internal prisoner housing compound). This area itself may be divided into two smaller components—prisoner housing and light industry/support. Located on the southeast side of this area is a U-shaped 25 meter by 70 meter two-story building that is used to house prisoners.¹⁹ What appears to be a partially completed wall on the east and southeast sides of this building was observed in the De-

ember 19, 2017 image. This and other low walls and fences appear to separate the prisoner housing building from the rest of the area. Scattered throughout the remainder of this area are approximately 15 small buildings that appear to be involved in some type of light-industry work, including one that appears to be for shipping and receiving. The exact nature of the light industry is unknown. There are numerous coal mines and quarries of various categories in this section of Kangdong-gun and it is possible that prisoners from the Pokchŏng-ni *Kyo-hwa-so* may be engaged in forced labor in these industrial operations.

A close-up view of the main prisoner housing and support area on December 19, 2017. Approximately 15 people can be seen on the west end of the prisoner housing building.

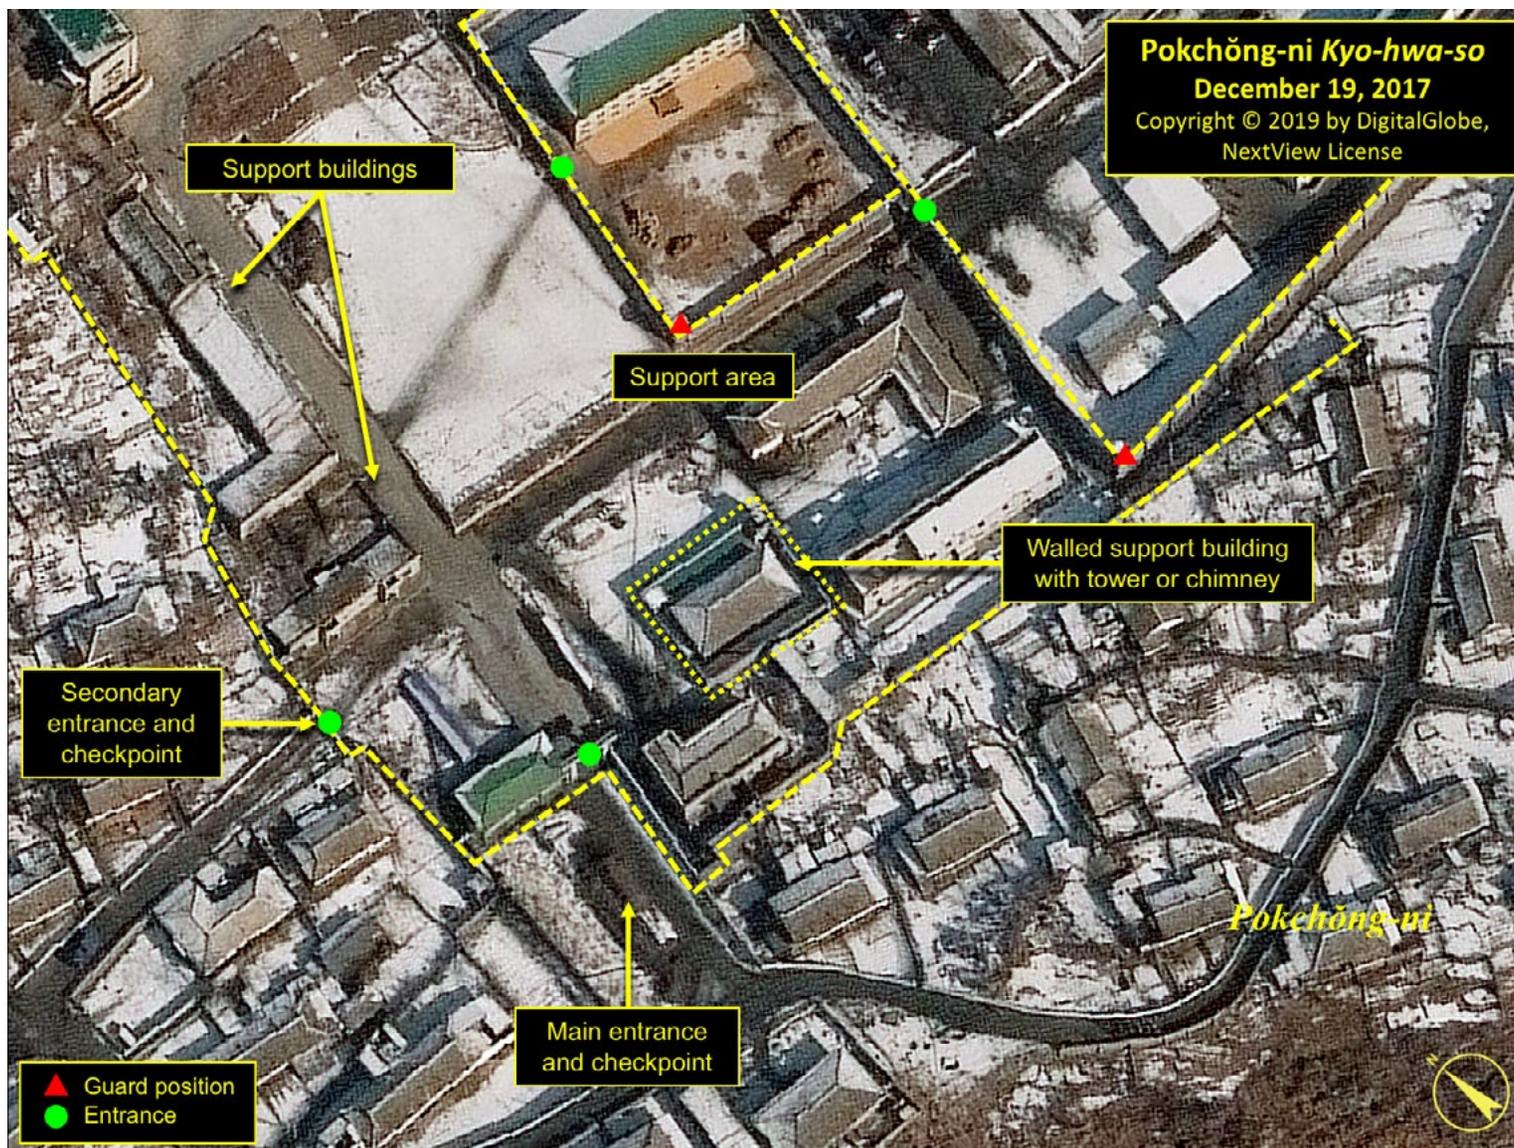
Figure 15

Located south of the headquarters and administration area, and along the western and southern walls, are approximately eleven support buildings, including the main entrance/checkpoint office. All these structures are typical based on similar structures found at *kyo-hwa-so* around North Korea. One, however, is worth noting. It is a small rectangular building surrounded by a high wall measuring 25 meters by 19 meters that has an elevated structure, which could potentially be a guard tower or chimney, on the northeast corner of the wall. It is unclear what the purpose of this building is.

A close-up view of the support area on the south side of the facility on December 19, 2017. Of note is a small building surrounded by a high wall and a small elevated structure (potentially a guard tower or chimney) attached to it.
